- \* 8. Edgewater Manor update, and action relating to the needed façade work.

WJH&A Project No.: 13082

***Onsite Masonry Veneer Evaluation***

Edgewater Manor  
1450 Water Street  
Stevens Point, WI

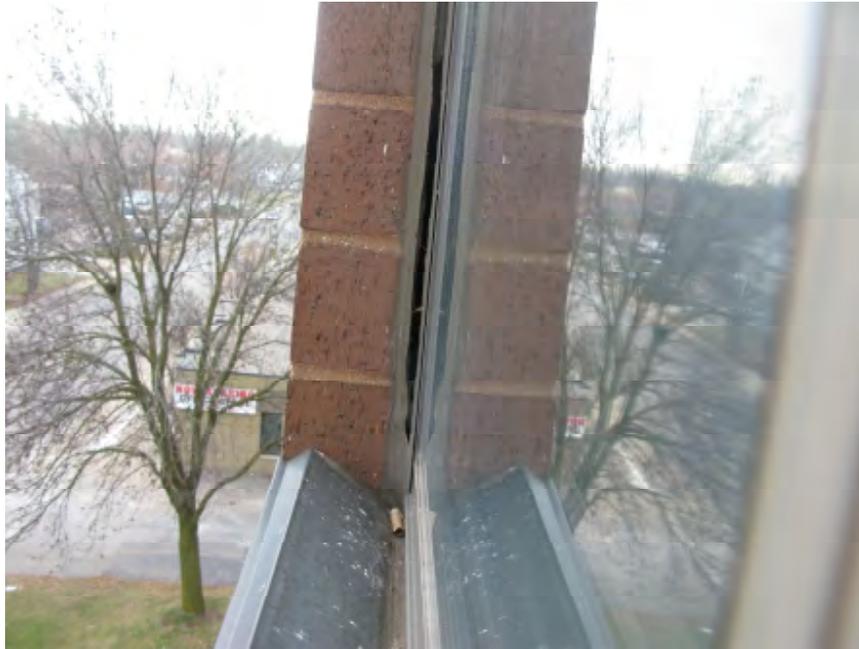
- Bedroom window exterior sill flashing has rotated upwards (Photo Nos. 1 & 2).
- Perimeter sealant around the windows has failed cohesively (Photo Nos. 1, 3-5).
- A straight edge was set against the wall to evaluate the offset of the dislodged brick (Photo No. 6).
- Window assembly has settled approximately  $\frac{1}{4}$ - $\frac{3}{8}$ " (Photo No. 7).
- There is a significant amount of mortar droppings behind the brick veneer, there is no mortar netting (Photo No. 8).
- The windows are sealed to the brick veneer; there is no weather barrier behind the veneer (Photo No. 9).
- Water staining is present below the window corners on the exterior sheathing (Photo No. 10).
- Some of the galvanized masonry veneer anchors are being pulled away from the wall as the brick veneer is dislodging (Photo No. 11).

Photo No. 1- Exterior sill flashing rotated upwards, and failed perimeter sealant

- Install a #14 fastener with a 3” diameter washer through the horizontal mortar joints at displaced areas into the structure / stud framing to retain the brick. Fasteners should be placed on a 24” o.c. grid or less.
- Remove all sill flashings which are back pitched and temporarily attach and seal them to the window sill to promote proper drainage.
- Re-caulk the open or failed sealant joints to limit the water migration into the cavity.

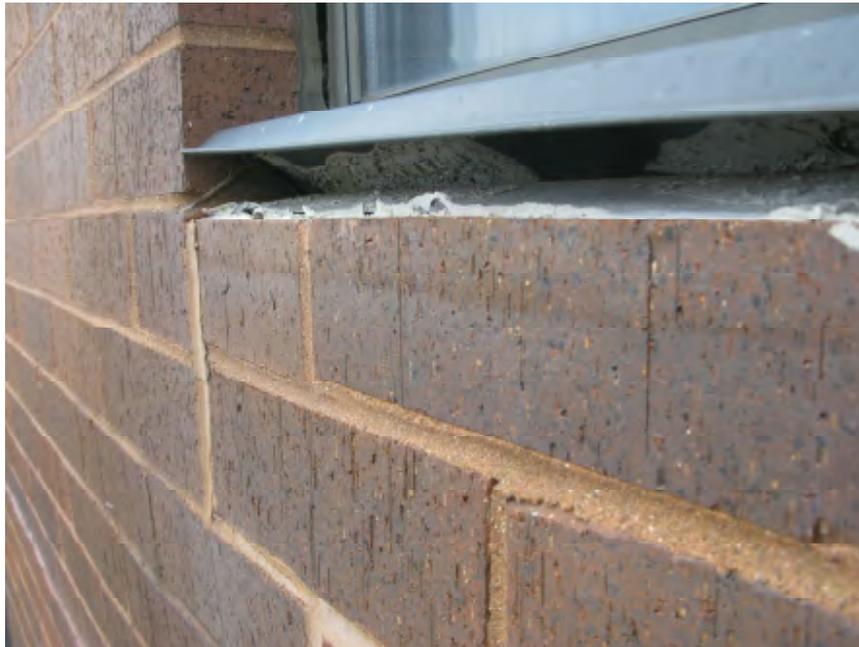
Photo No. 2- Rotated exterior sill flashing

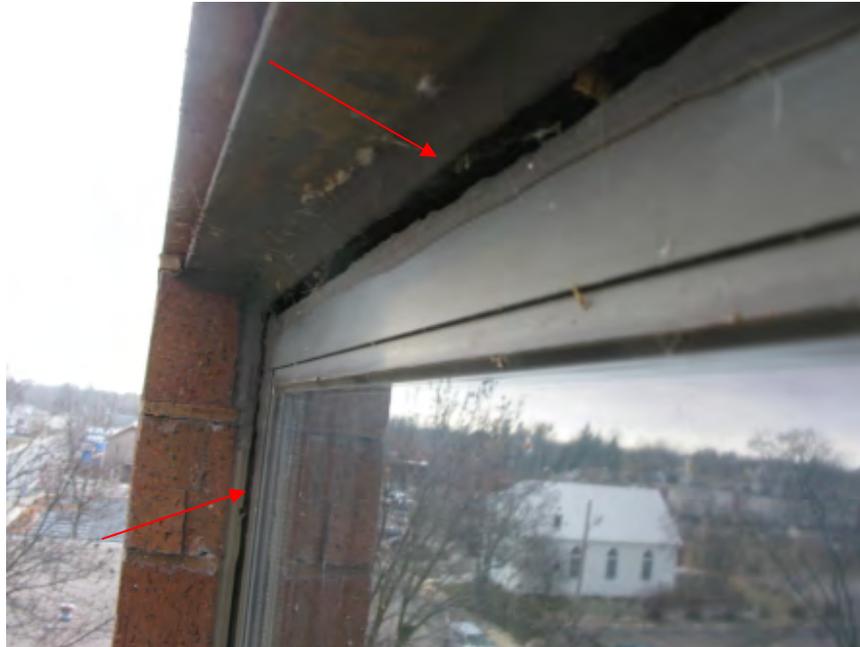
Photo No. 3- Window perimeter sealant failure

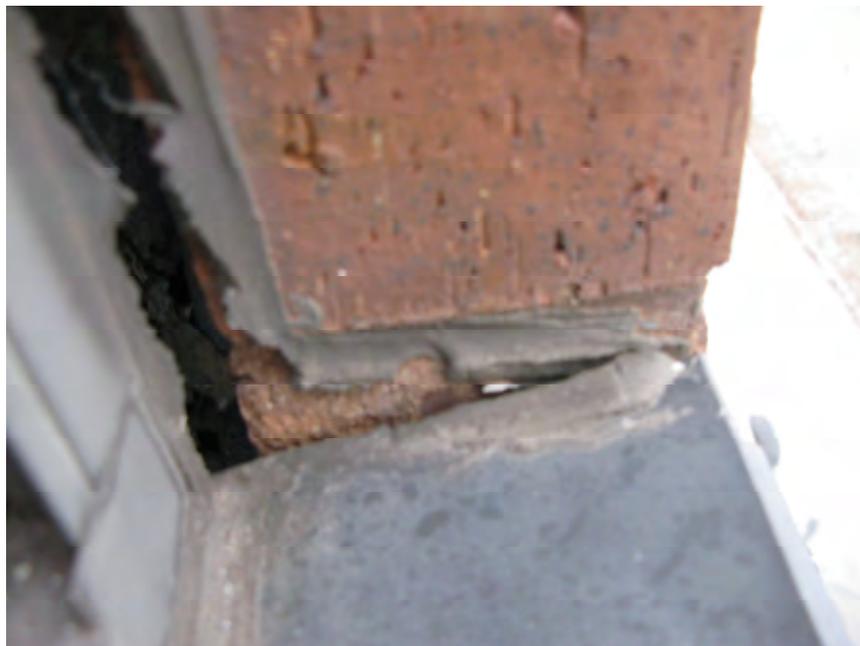
Photo No. 4- Window perimeter sealant failure, brick shifted to the exterior

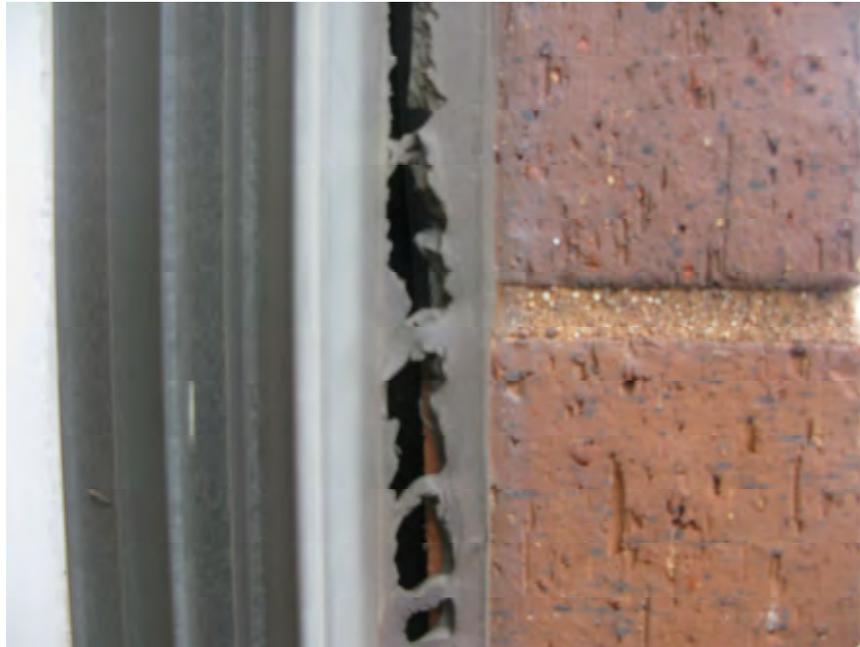
Photo No. 5- Window perimeter sealant failure

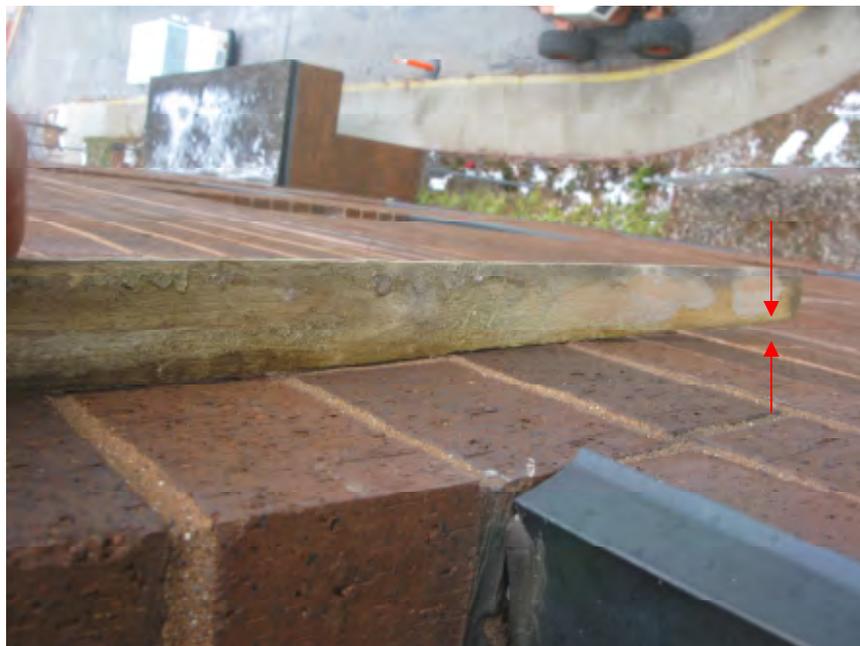
Photo No. 6- Straight edge approximately 1" from the face of the brick

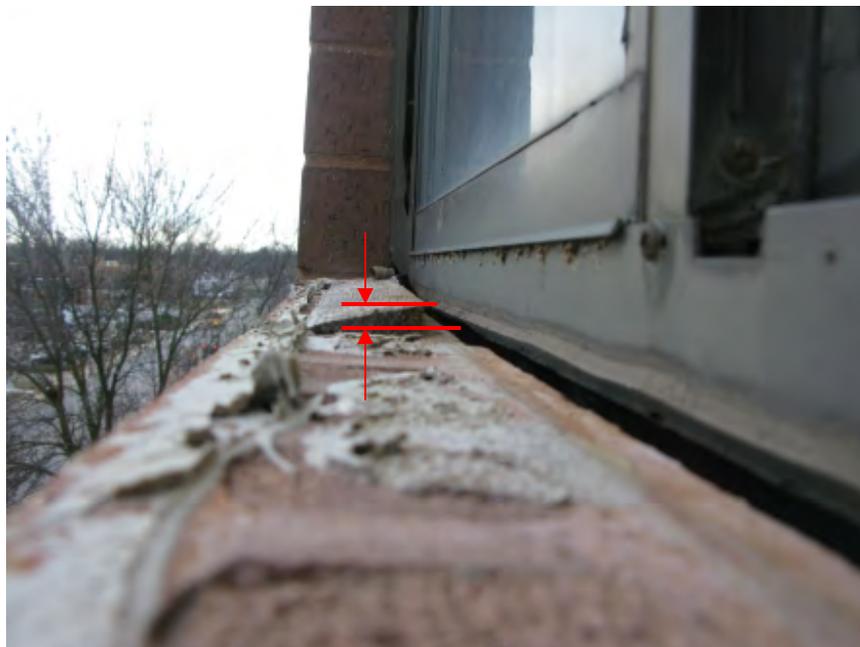
Photo No. 7- Window has settled, the top line is the location of the sill flashing which the window previously set on; the lower line is the approximate location of the bottom of the window currently.

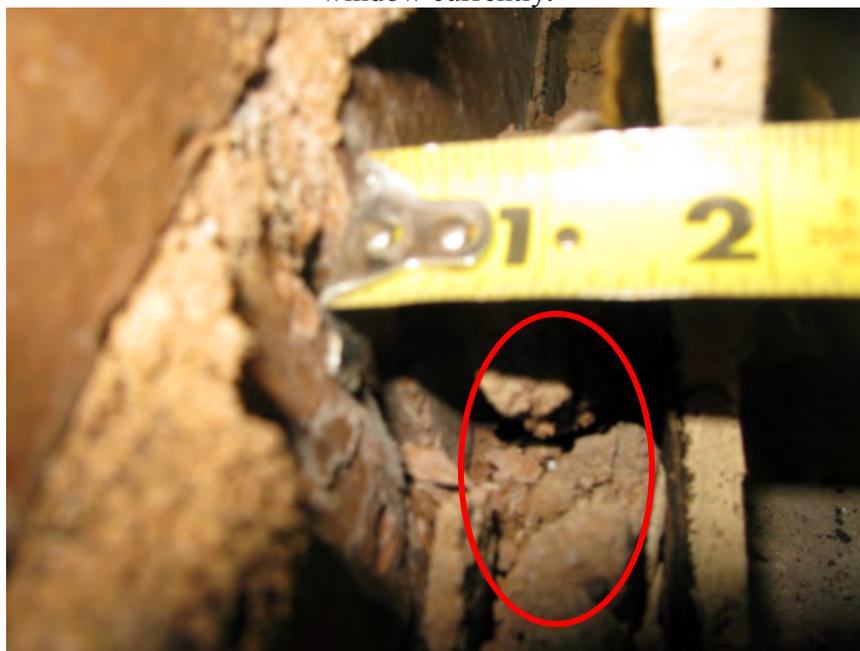
Photo No. 8- Mortar droppings in the brick/ drainage cavity.

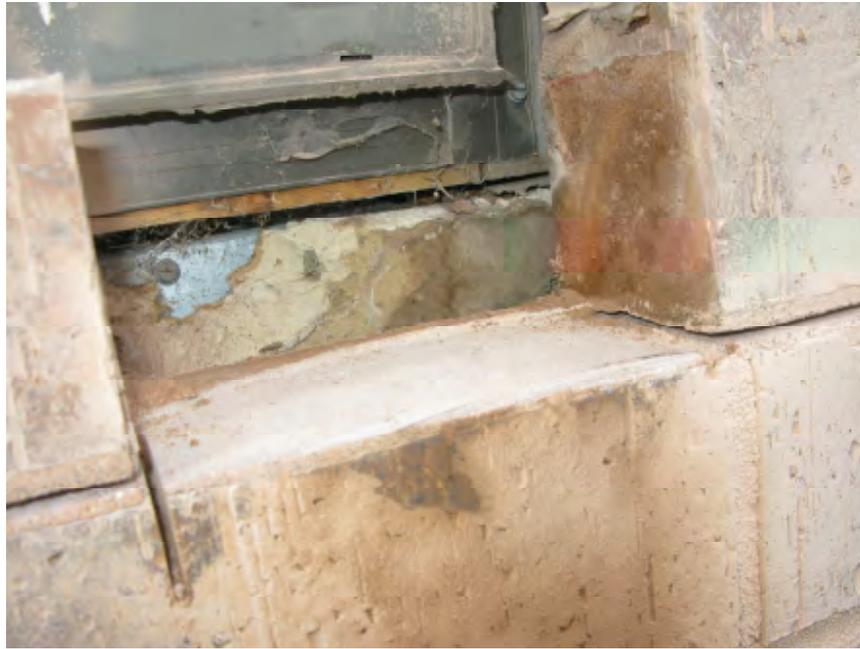
Photo No. 9- Exterior sheathing with no weather barrier, the window is only sealed to the brick veneer

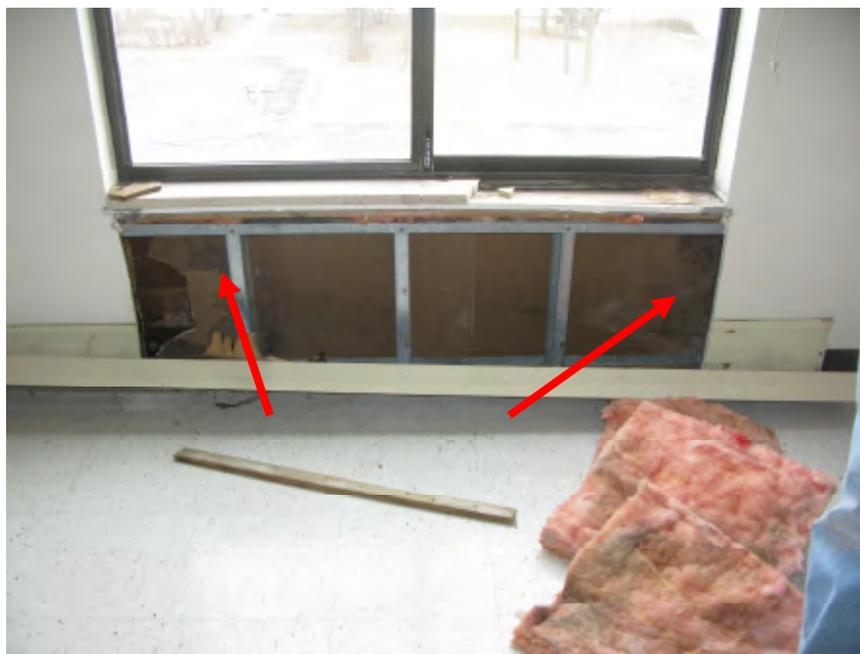
Factors contributing to the volume of water or moisture within the air cavity include water absorption through the brick veneer, failed sealant joints in the veneer and around the windows, vapor diffusion from interior to exterior, and water leakage from the windows at the frame joinery (signs of water leakage below the window on the sheathing).

Photo No. 10- Water staining on the exterior sheathing below the window corners

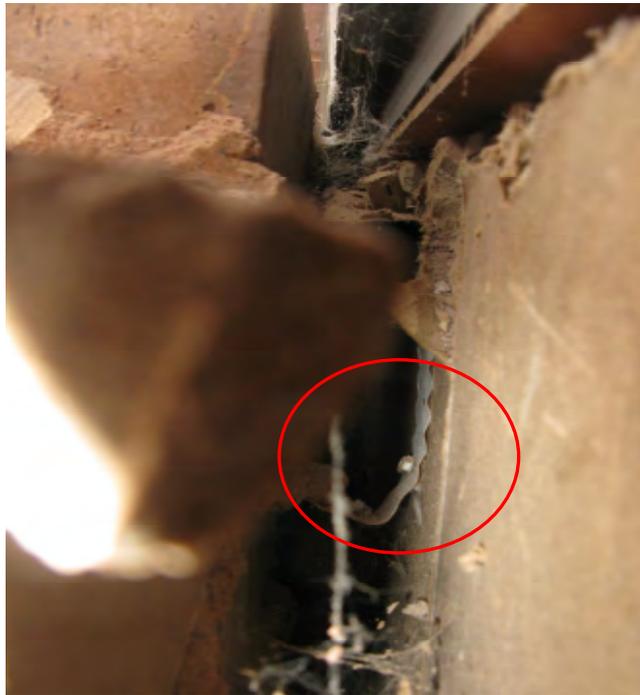
Photo No. 11- The brick tie adjacent to the dislodging veneer is being pulled away from the wall

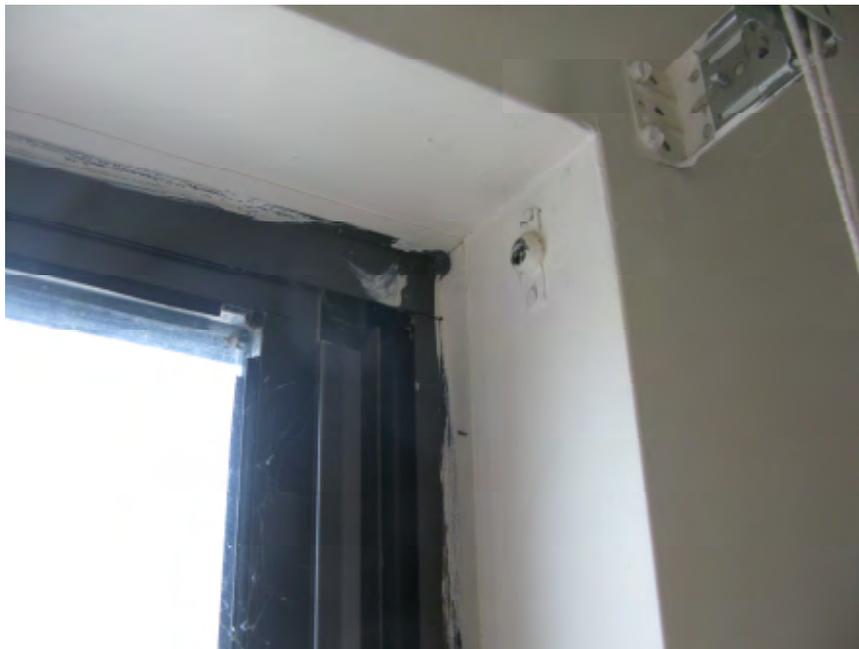
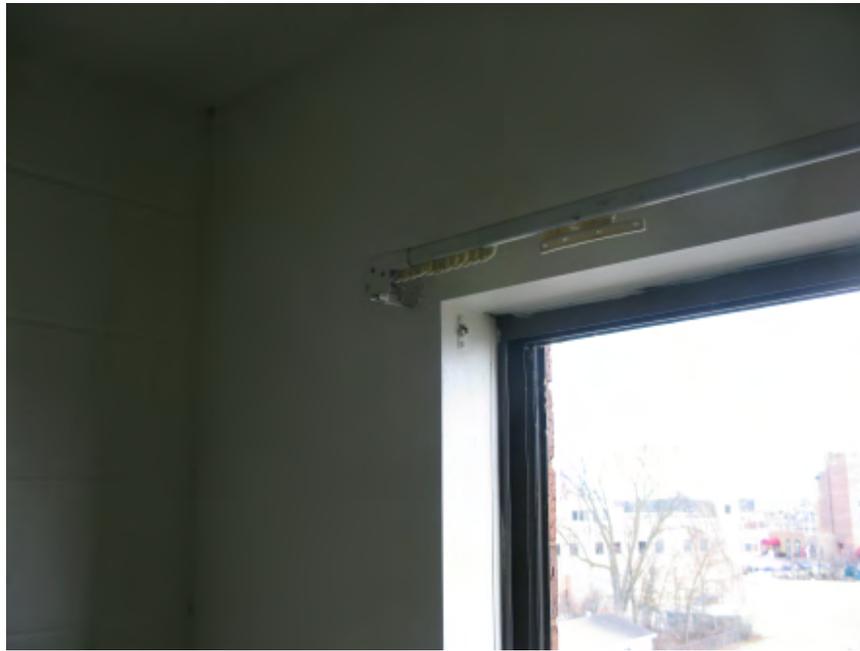
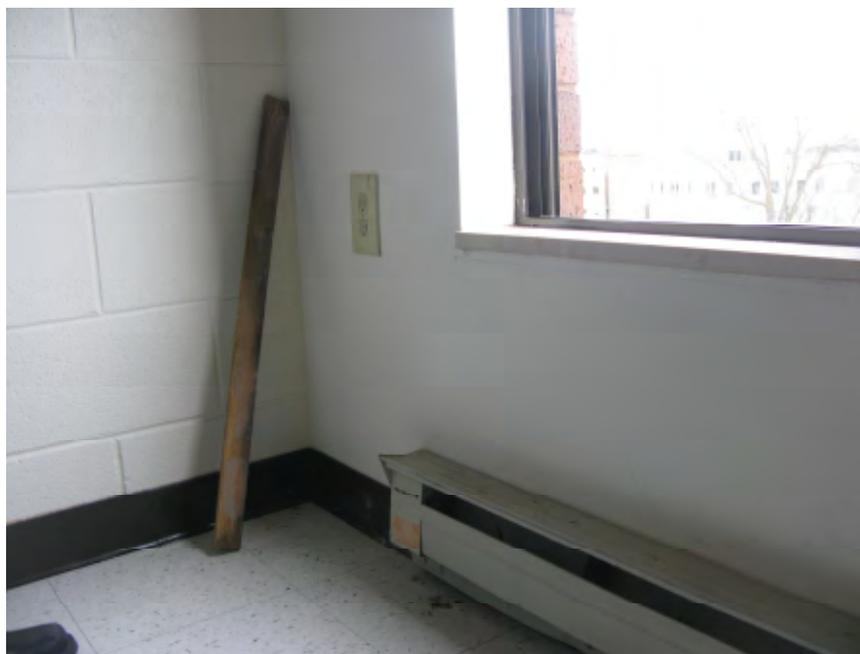
Photo No. 12- Interior view, Bedroom 506

- There are no current signs of movement or damage to the interior finishes (Photo Nos. 12-14).
- The steel shelf angle is concealed by the horizontal control joint sealants (Photo No. 15).
- The masonry veneer wall assembly is constructed from exterior to interior as follows:
  - Brick veneer
  - Air cavity
  - Exterior sheathing board
  - Metal stud framing with batt insulation set on top of the floor slab
  - Interior drywall

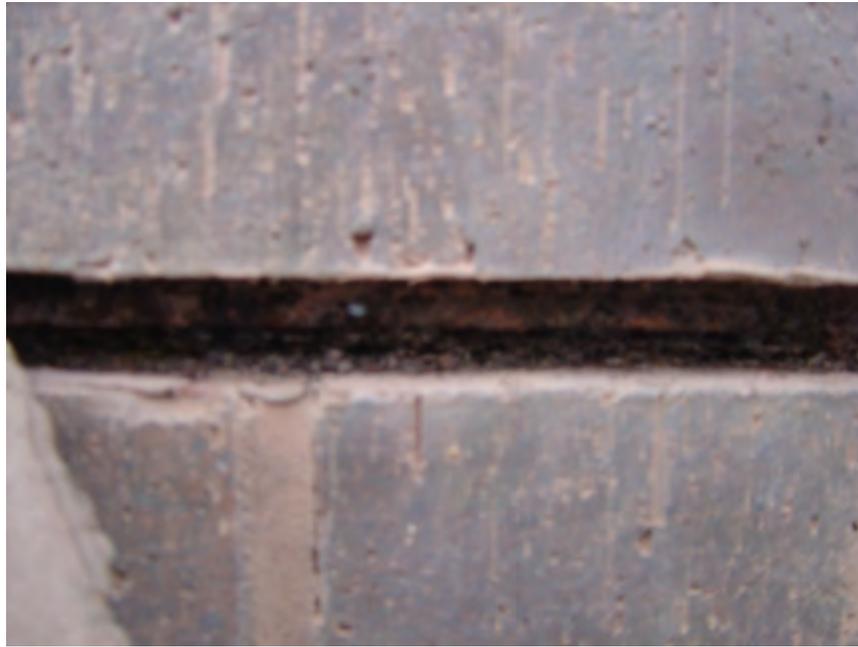
Photo No. 15- Control joint at steel shelf angle (sealant removed)

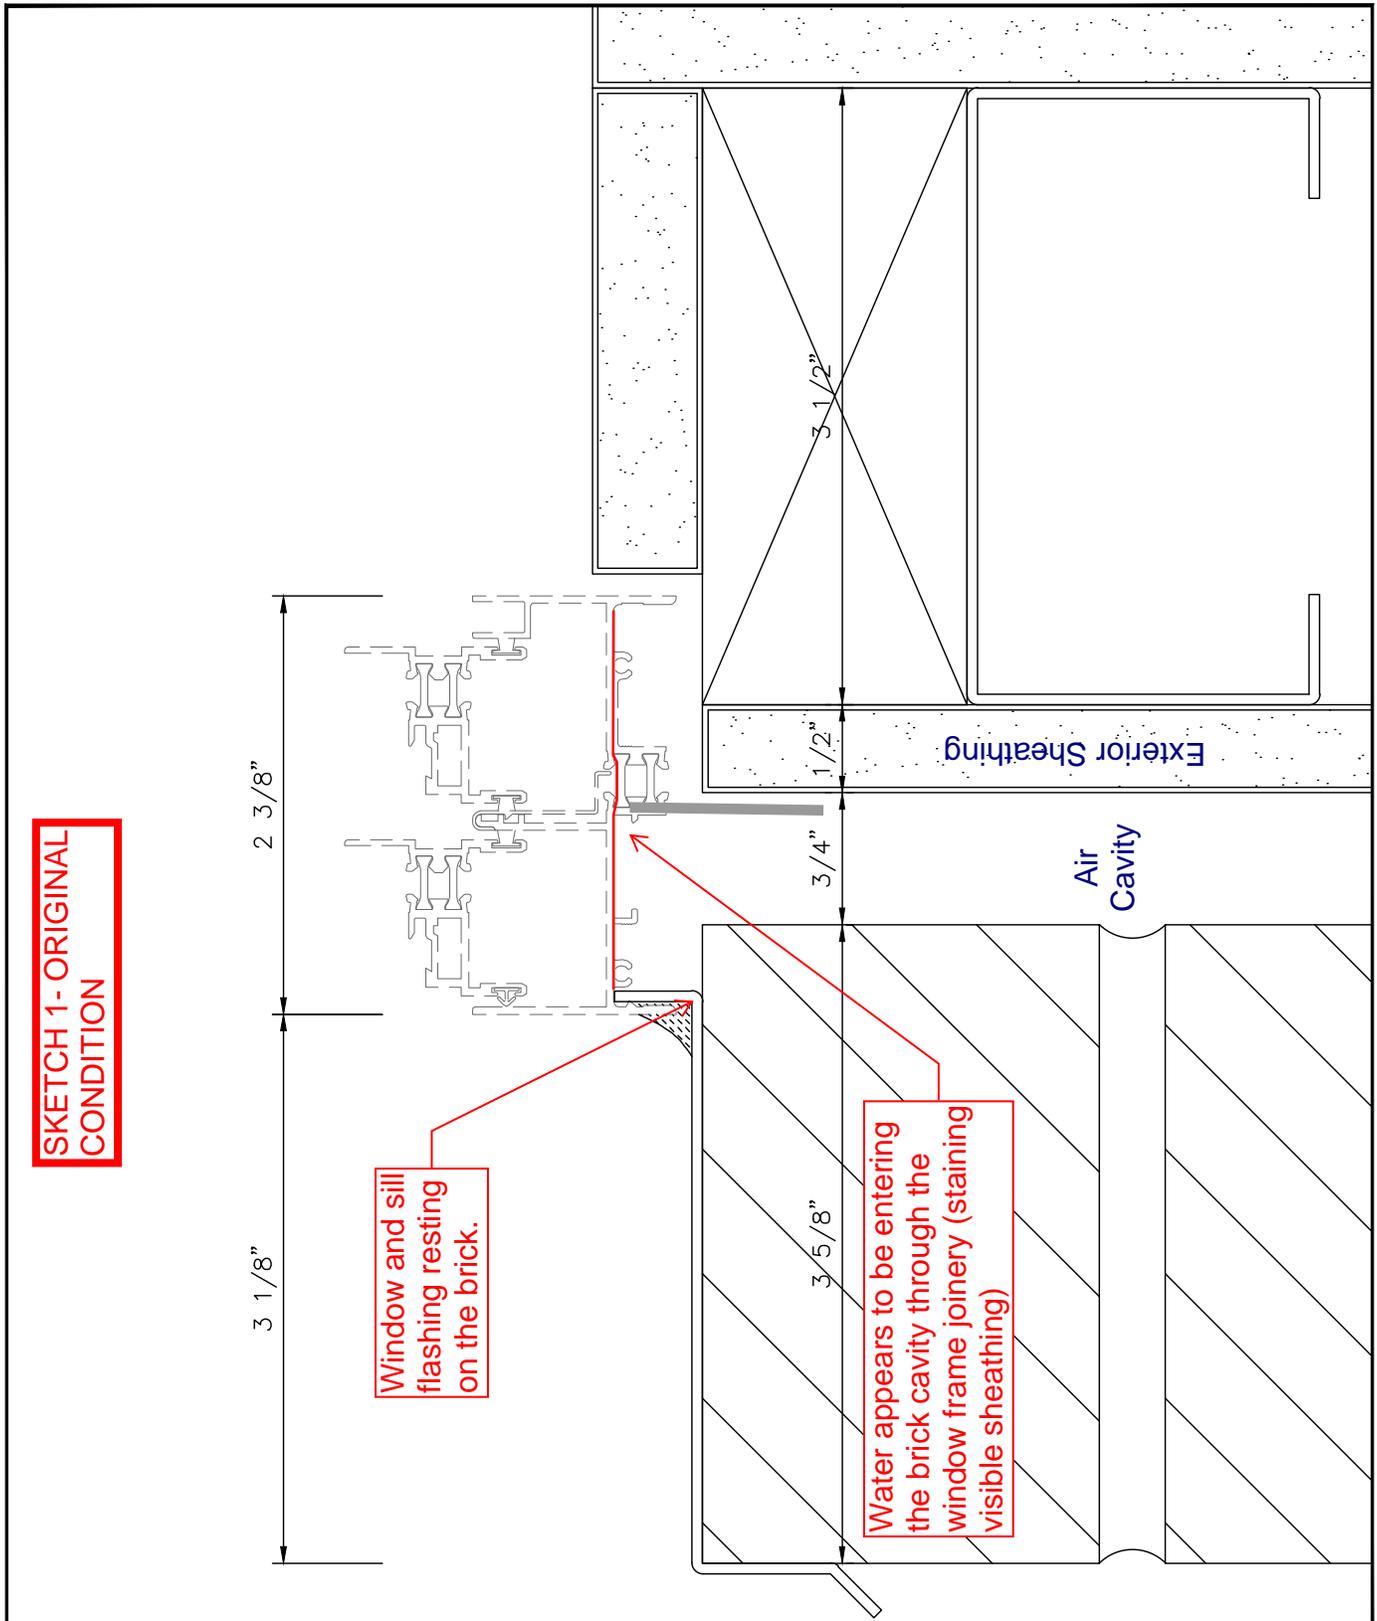
SKETCH 1- ORIGINAL  
CONDITION

As a direct result of the displaced brick veneer at various locations the window assembly and exterior sill flashing which previously set on the inner edge of the brick (reference Sketch 1) are no longer supported by the brick allowing the window to settle slightly tipping the flashing upward (reference Sketch 2) and causing the window sealants to tear or fail cohesively. With the sill flashing back-pitched and the window perimeter sealants failing there is the reality of increased potential for water entry into the air cavity which again cannot be effectively drained further aggravating the root cause.

Window and sill  
flashing resting  
on the brick.

Water appears to be entering  
the brick cavity through the  
window frame joinery (staining  
visible sheathing)

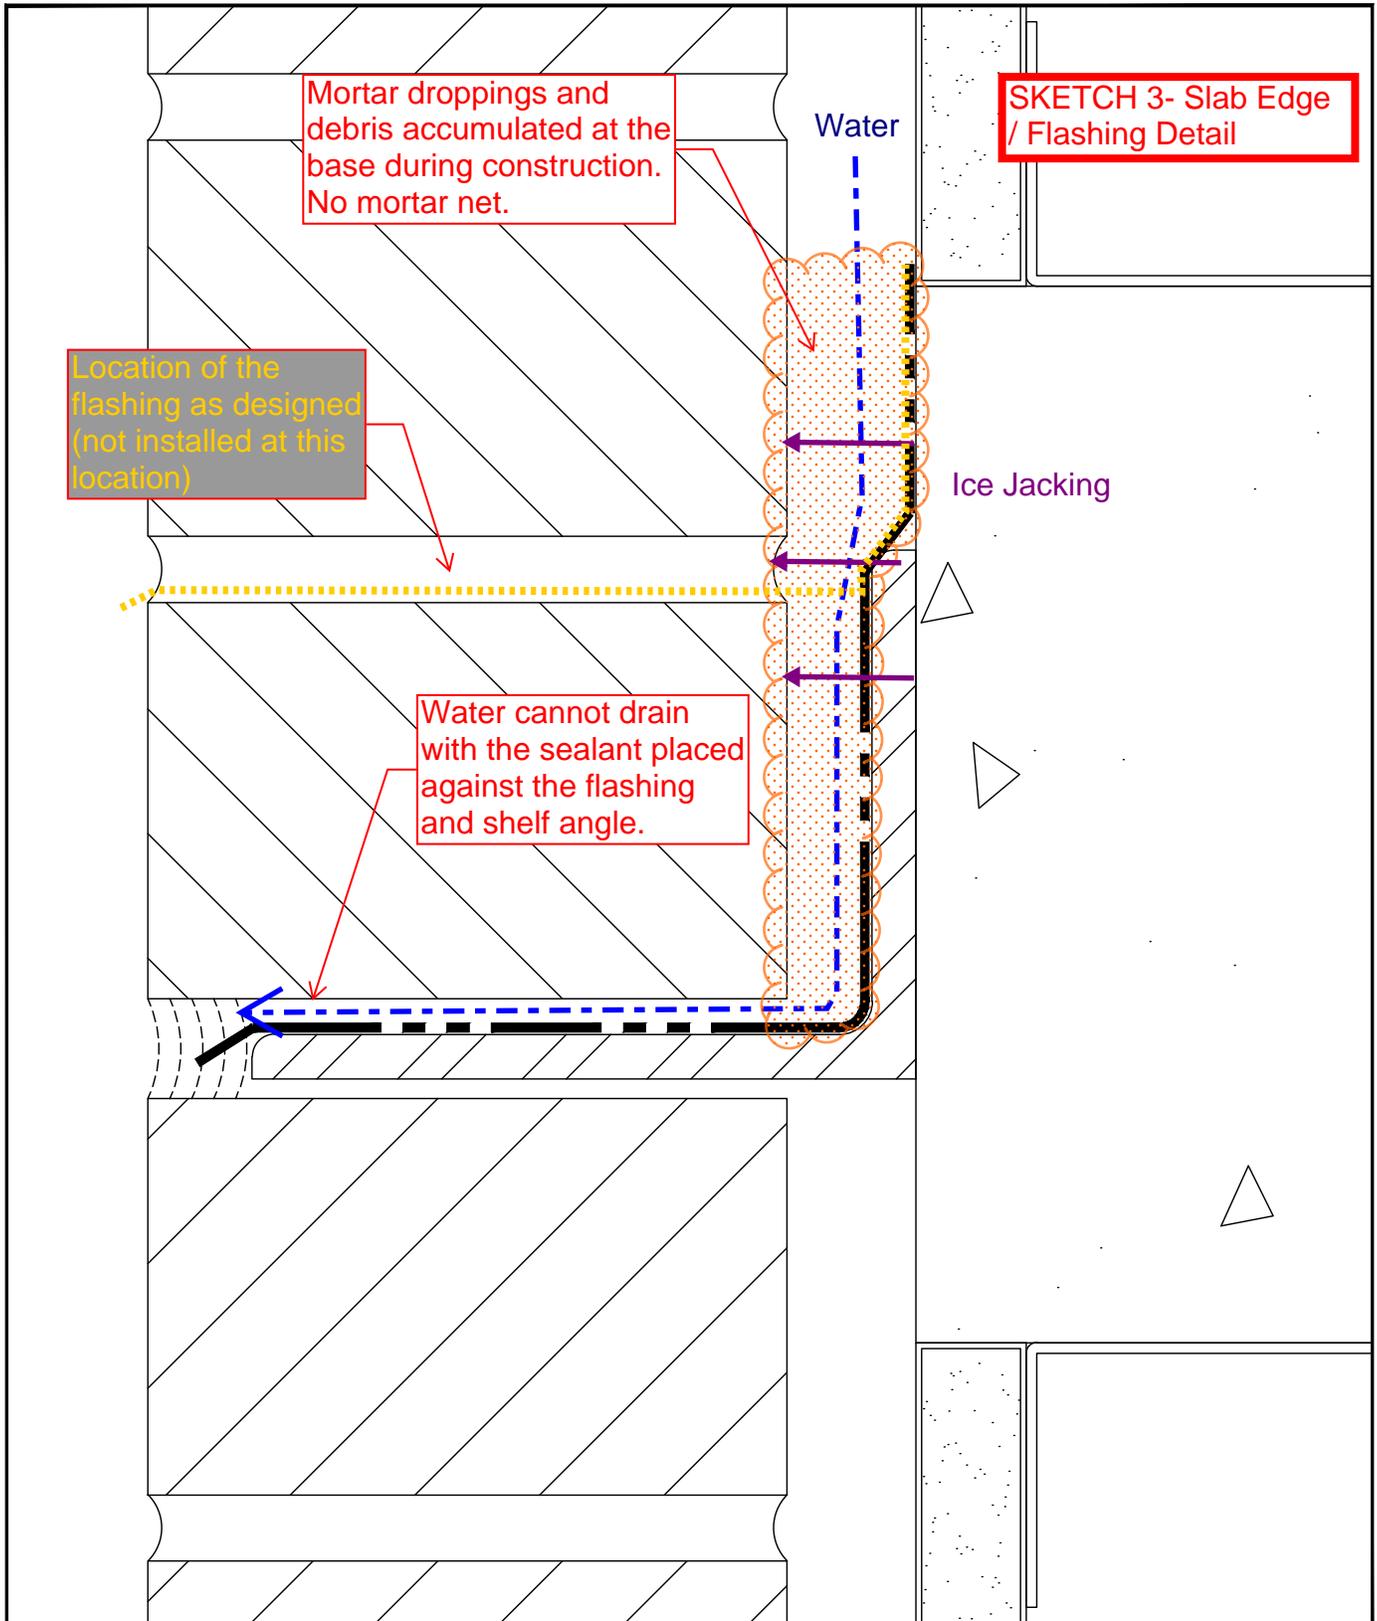
Sheet No.: D3  
 Job Number:

We have considered performing limited renovations to the failing areas; however we cannot guarantee that this process will not continue to occur at other areas. If desired we are willing to discuss this option further but do not believe that is a good long-term option; our opinion regarding this is based on the in-ability for the flashings to effectively drain (depicted on Sketch 3).

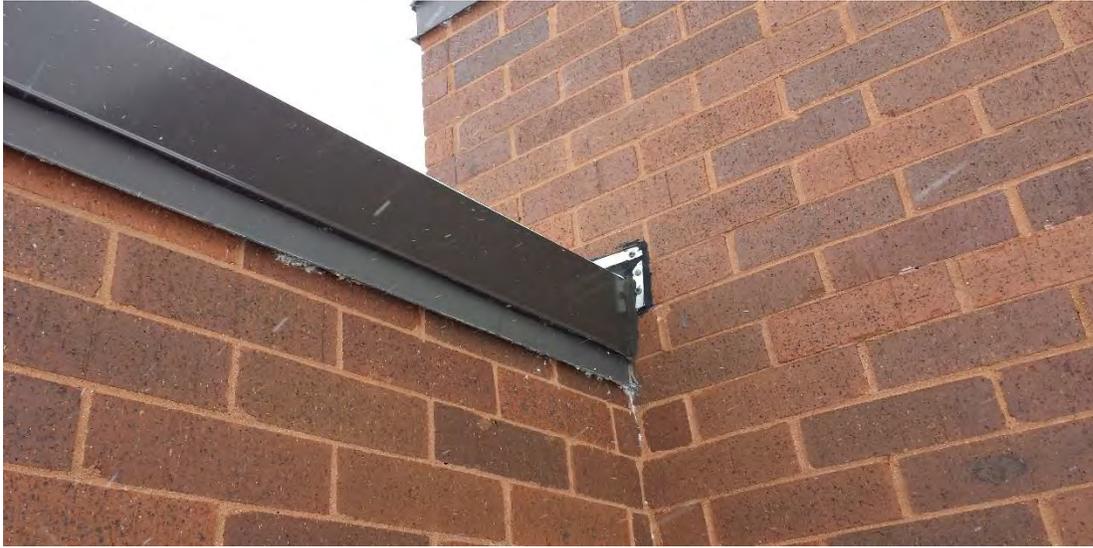
The photo above is consistent with the look of the brick throughout the outside of the building. The mortar is sound, bricks are solid and show little signs of wear and tear. The phot below shows the metal ties. The brick is anchored to the metal studding in each veneer section with ties like this approximately every sixteen inches on center in each direction. They are built to move with the veneer for expansion and contraction. The water that penetrates the brick through normal weather conditions normally runs down the back of the brick; it does not reach the gypsum board that was removed between this stud and the brick. This picture is taken from under the window in room 506.

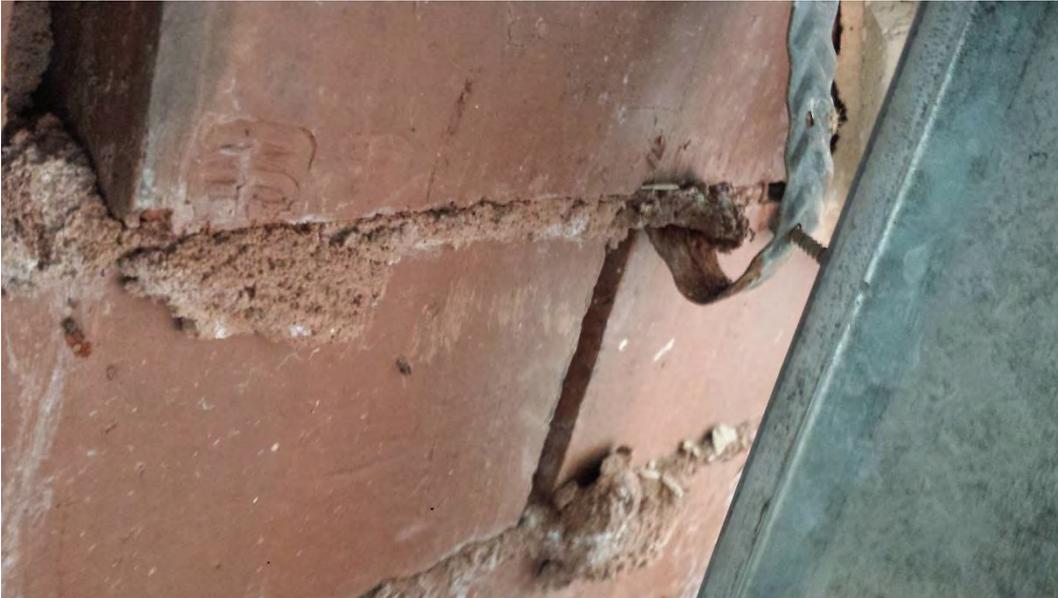
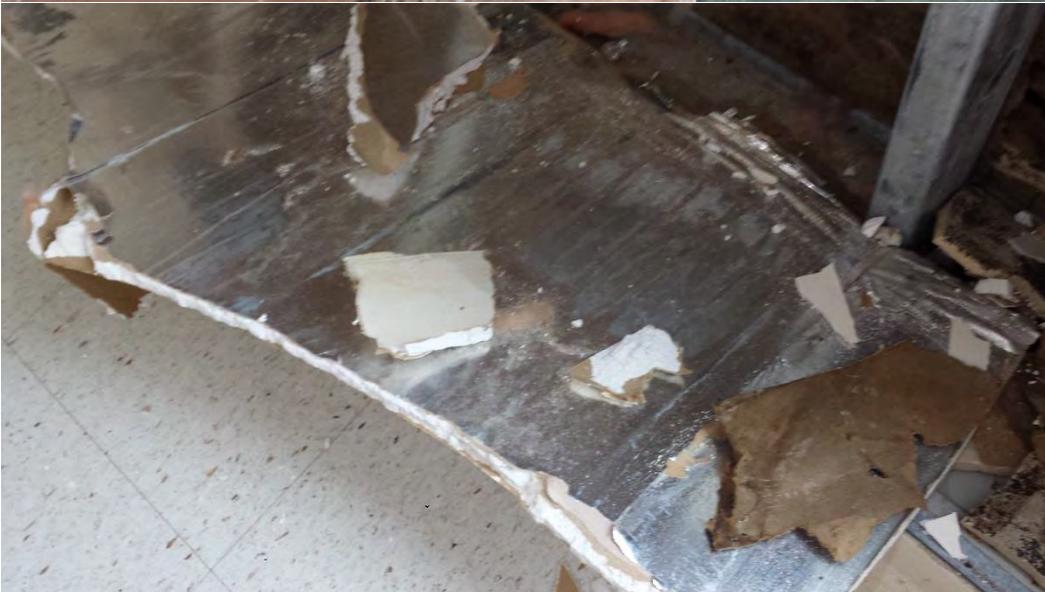
This photo displays the the foil backing connected to the back of the drywall adjacent to the damaged window in room 506. It is this barrier that is most likely missing in the units in which the studs are able to be seen through the drywall. This barrier is to prevent the moisture from the units from entering the wall cavity. This wall is built to breathe to the exterior and that is why there is no moisture barrier connected to the gypsum board behind the brick. The air cavity and weep system provide ample ventilation for the wall. The moisture content of the gypsum board between the insulation and brick in room 506 was 15% on this day. This spot was opened on the same day it was moisture tested to get an accurate result. This evidence indicates that the original construction and design is still functional in its correct application even 30-40 years after it was built.
