REPORT OF THE HISTORIC PRESERVATION / DESIGN REVIEW COMMISSION

Wednesday July 6, 2016 –4:30 p.m.

2. Request from AJ Filtz, representing McDonald Title, for design review approval to perform exterior facade improvements which includes the installation of a stucco finishing system at **1059 Clark Street (Parcel ID 2408-32-2020-01)**.

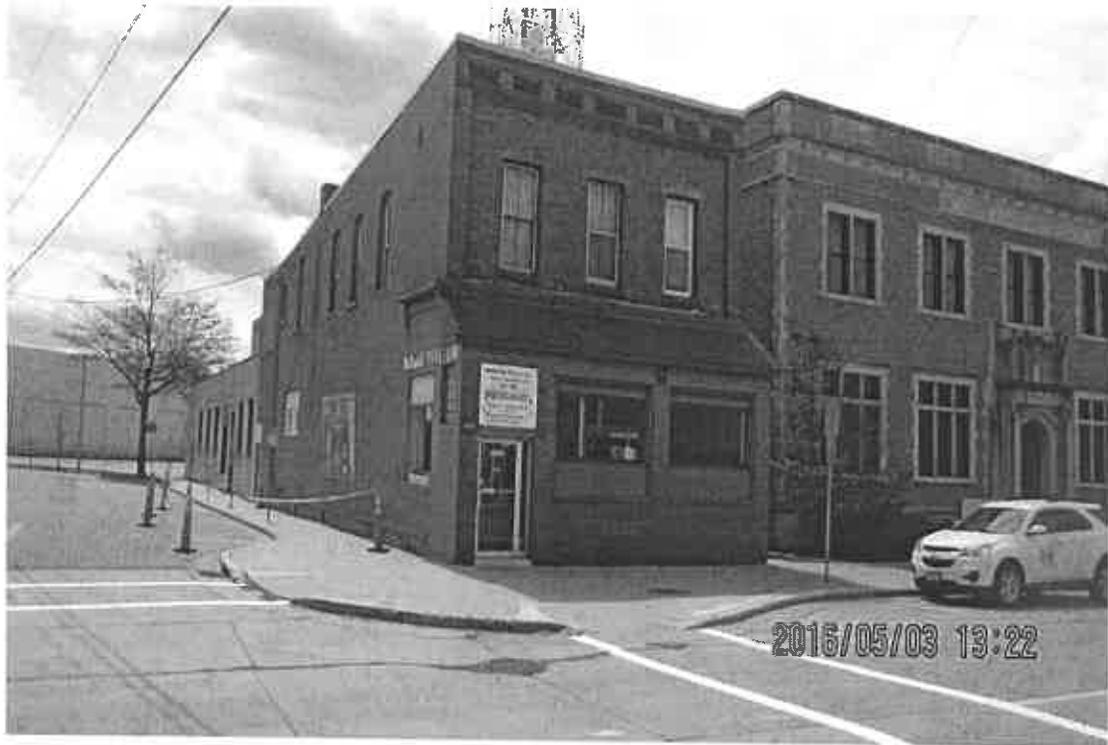
Northeast building elevation.

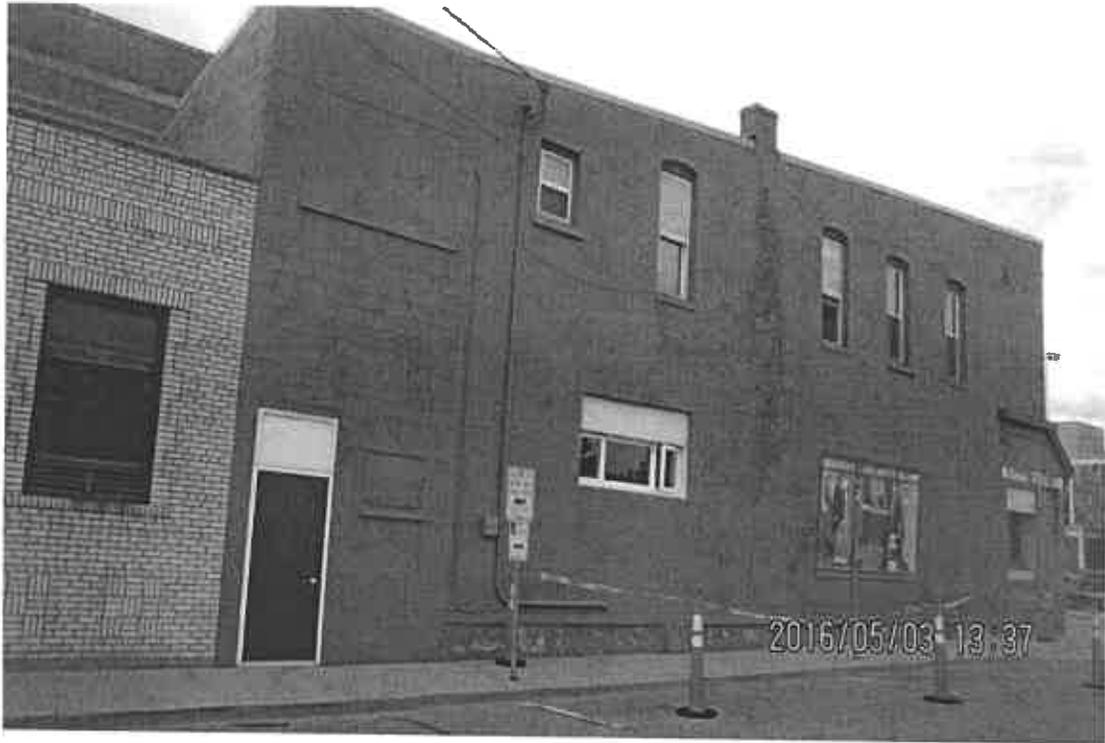
- D. During the spring of 2016, the insured observed separation of the brick from the exterior wall at the windows on the east side of the building and a significant leaning of the brick veneer panel away from the exterior wall on that same side.

- H. A brick chimney is located at the east exterior wall approximately 40-feet from the front building corner. There is considerable discoloration of the east brick wall directly below the chimney for nearly its full height. The discoloration is accompanied by deterioration of the brick surface and the masonry joints. The balance of the brick on this wall exhibits only minor discoloration.

East exterior wall.

- A. The brick veneer on the east wall no longer functions as intended and requires repair. It is expected that the veneer may be removed without affecting the structural integrity of the building shell, but this requires verification by a licensed professional engineer.
- B. Any and all demolition activity and reconstruction must be performed by a licensed contractor experienced in this type of work and must be completed under the direction of a professional engineer licensed in the State of Wisconsin.

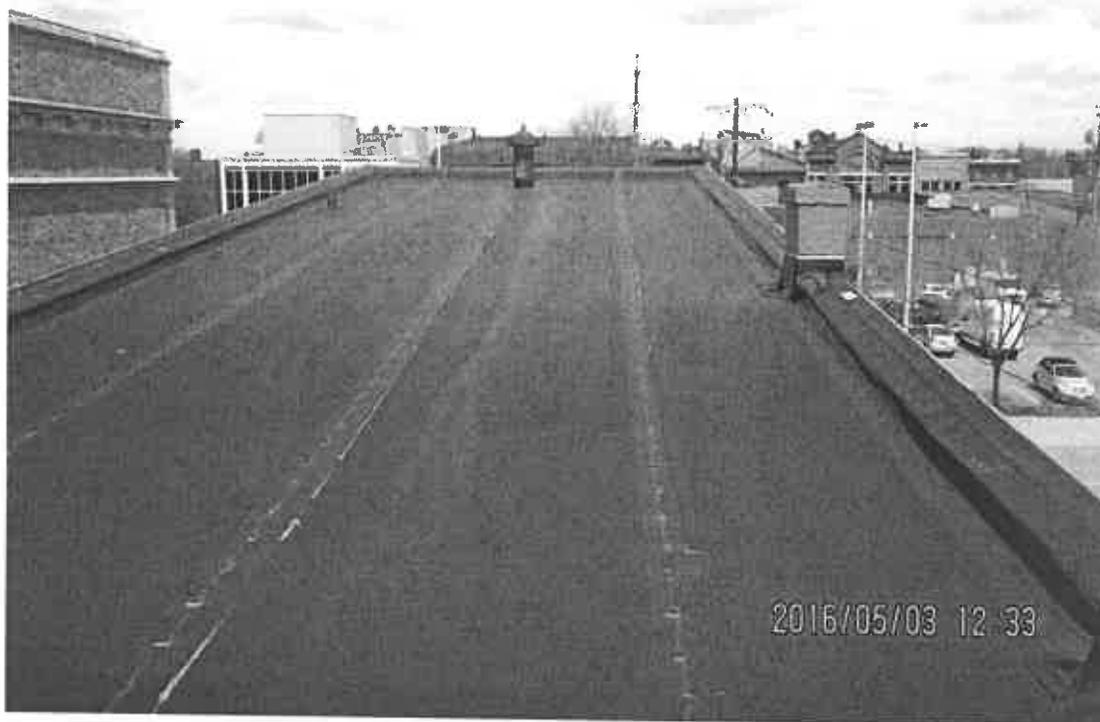
- 1. The existing roof is a 0.45 mil EPDM mechanically attached membrane system provided by Carlisle. The roof is in good condition and, as mentioned above, was installed within the past two (2) years based on information provided by the insured.

Roof facing north.

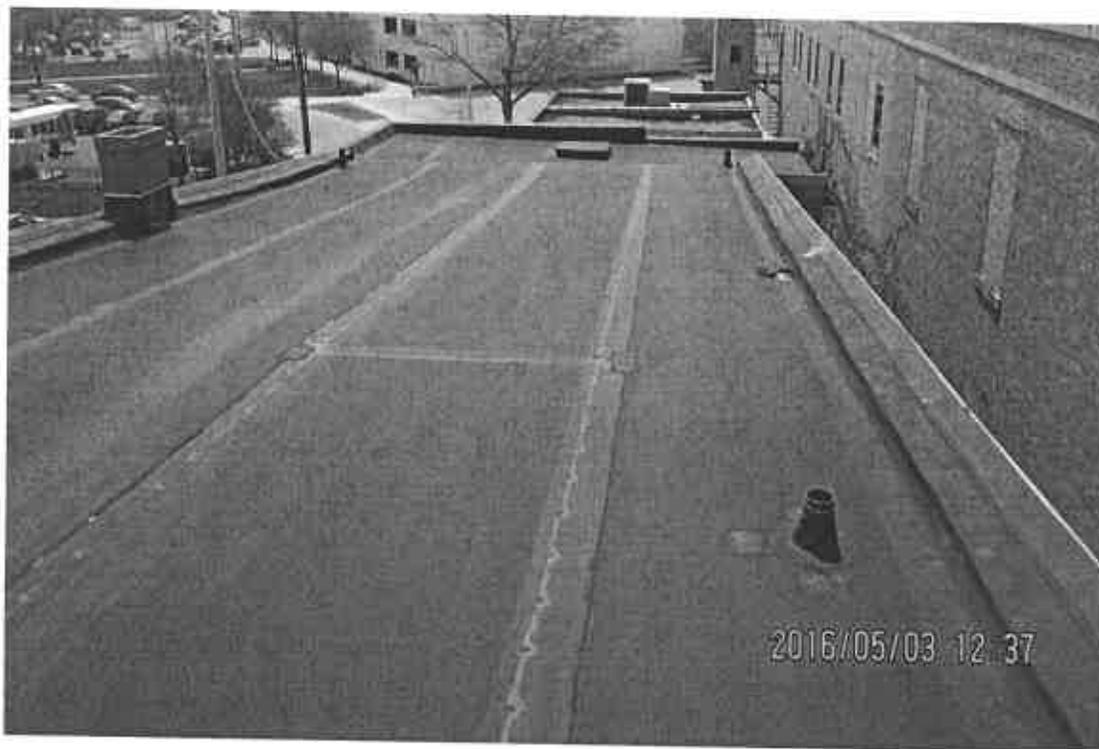
Roof facing south.

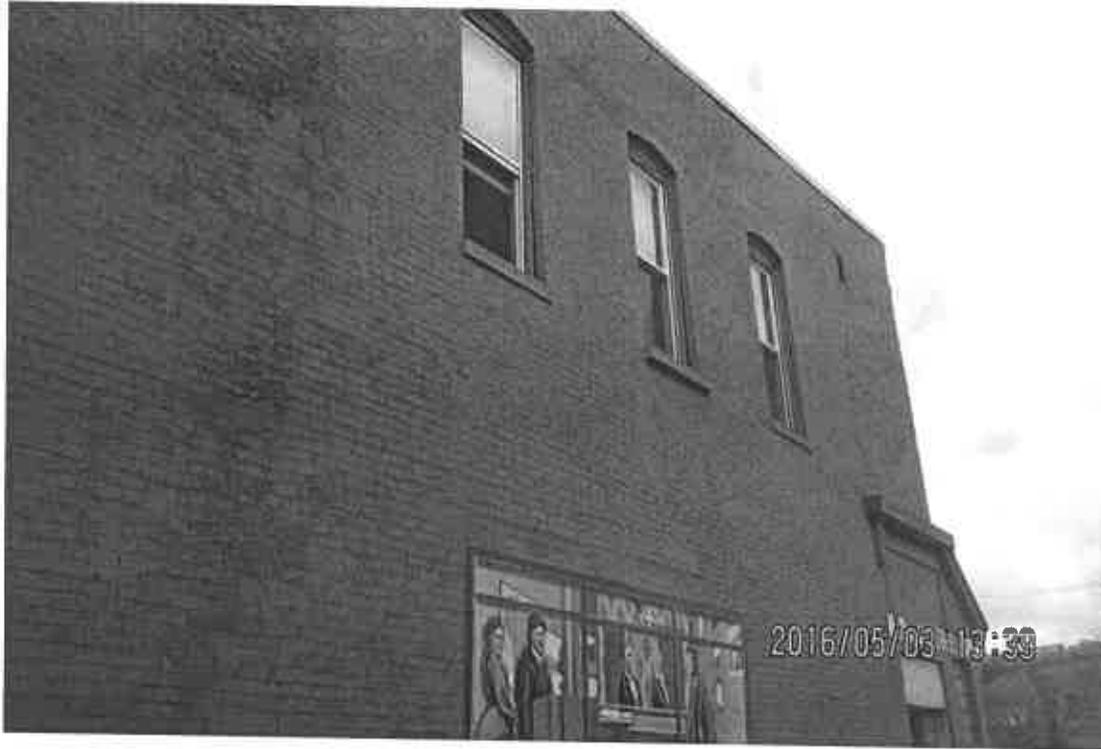
- a. Cracking and separation of the brick from the building frame were evident at all window sills and jambs. The separation varied from hairline to a maximum of 2.5-inches. The interior portion of the sills and jambs are constructed of wood framing in poor condition for the older windows and aluminum framing for the newer installations.

Second floor windows with brick veneer separation.

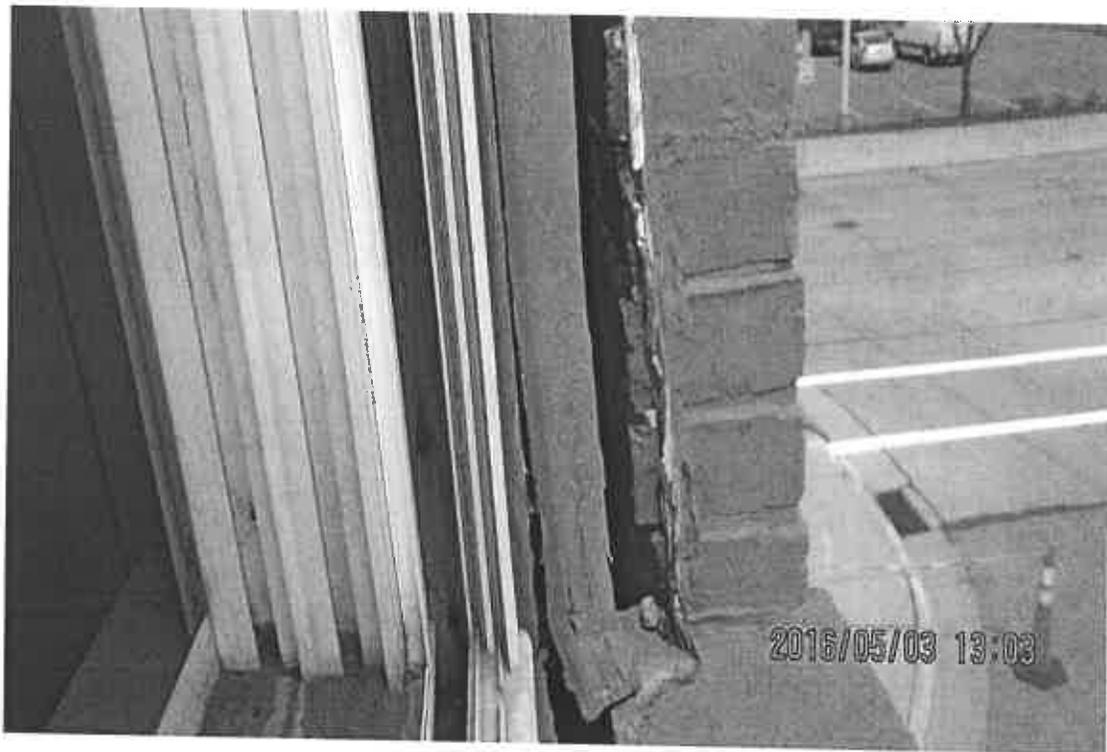
Second floor window with brick veneer separation at sill and jambs.

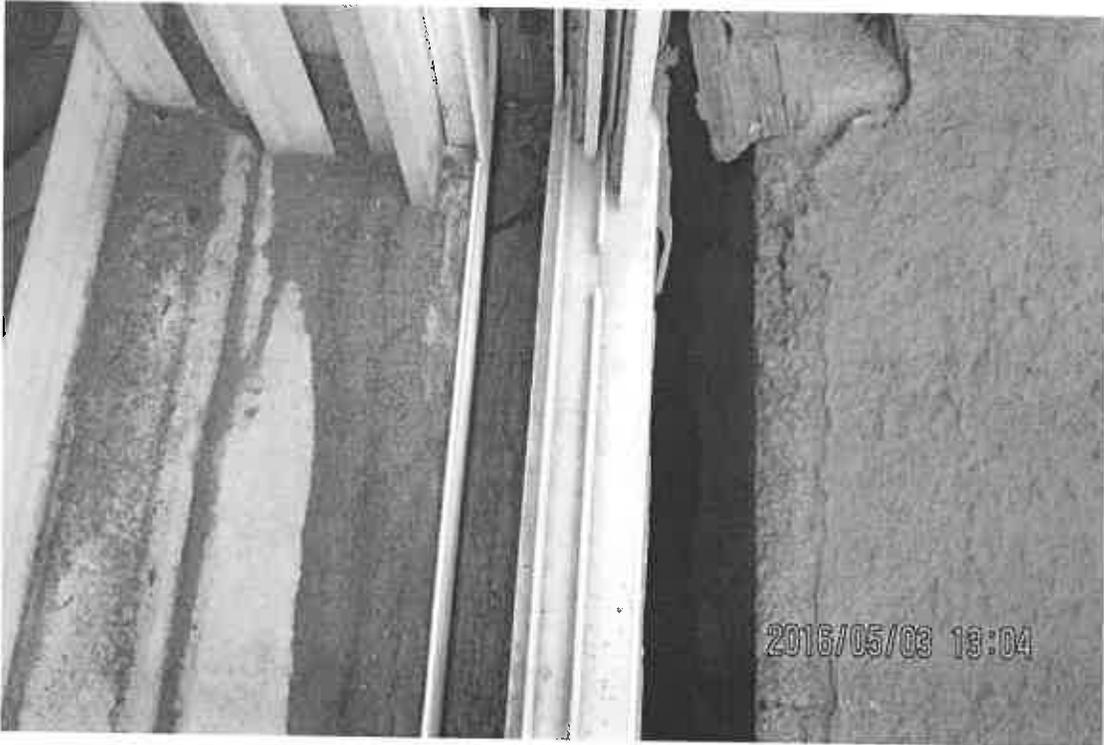
Separation of brick veneer from window at exterior wall.

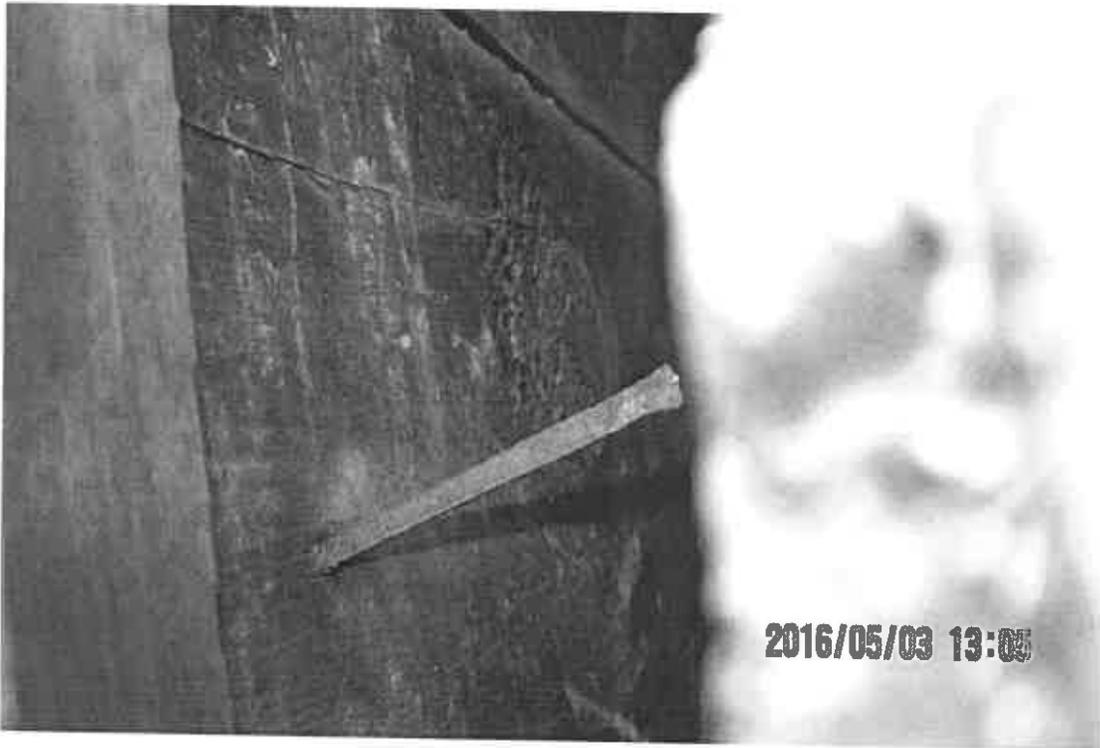
- d. Horizontal metal tabs were observed to be fastened to the wood wall system, but those that could be observed were not engaged with the brick veneer. It is expected that these tabs remain from the original system of ties that were embedded in the brick mortar joints and served to provide horizontal support for the veneer.

- e. The metal tabs that could be observed exhibited signs of severe corrosion.
- f. No horizontal brick ledger element along the length of the wall and near the second floor elevation was observed as would be expected in typical multi-story brick veneer construction. This feature is normally included, even in historic structures, to provide vertical and lateral support for the brick and allow for movements of the veneer system due to temperature and moisture fluctuations.

- C. It is expected that the primary deficiency in the current veneer system on the east wall involves the loss of horizontal support from the building shell framework to the brick veneer panel, due to the deterioration of the metal tie elements. The deterioration of the

metal tie system is attributed to long-term corrosive effects of uncontrolled moisture migration into the wall cavity.

- A. It is Pie's determination, based on a reasonable degree of engineering certainty that the loss of an effective horizontal veneer tie system is primarily causal to the current detached and deformed condition of the brick panel on the east wall. Although the original construction appears to have included a system of horizontal veneer ties that was likely standard for that era, the effects of uncontrolled bulk moisture entering the wall system over the life of the structure have severely corroded the ties to the point that those observed no longer engage the brick as required for stability of the veneer.

Wood exterior wall with corroded metal tie not engaged with brick veneer.
