AGENDA
HISTORIC PRESERVATION / DESIGN REVIEW COMMISSION
(SPECIAL MEETING)

Reconstruct Facade - Design Review
1141-57 Main Street
September 16, 2015

Project Name: Jensen Building: East Wall Condition Assessment
1147 Main Street
Stevens Point, WI
Ionic Project Number: 14-026

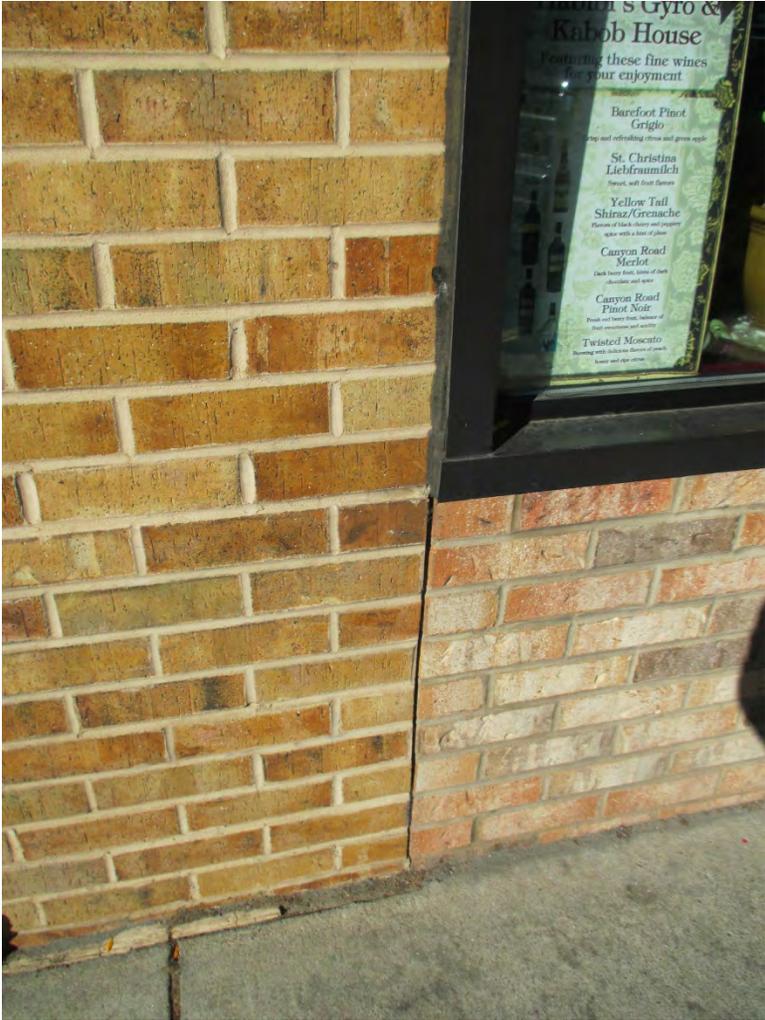
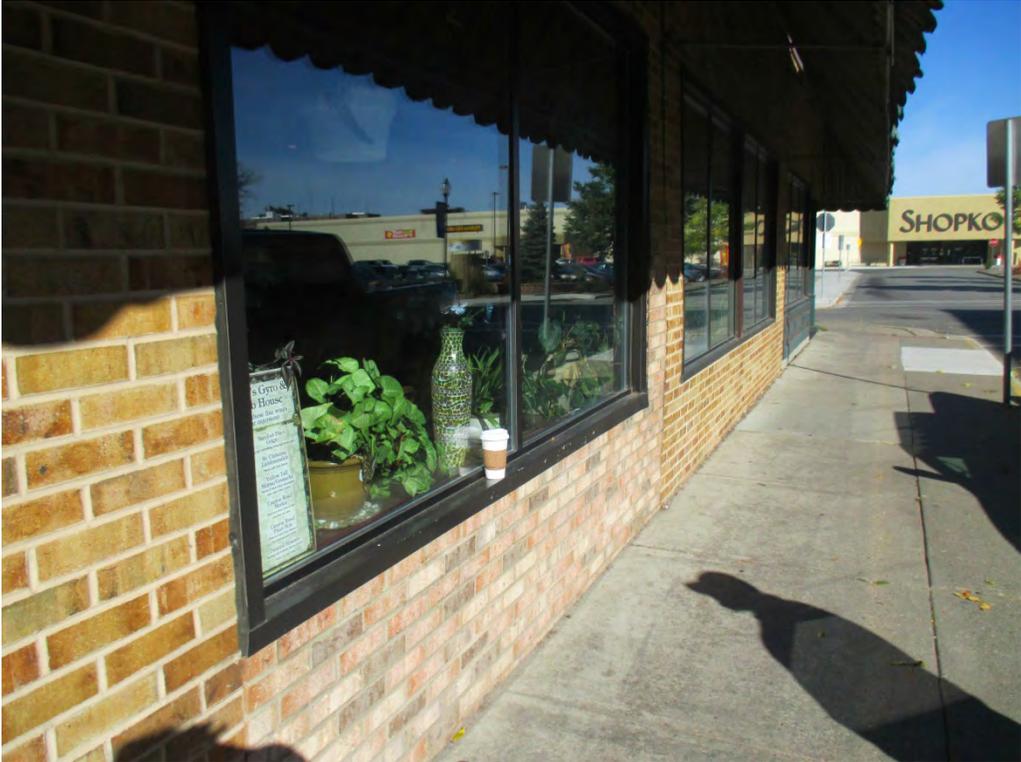
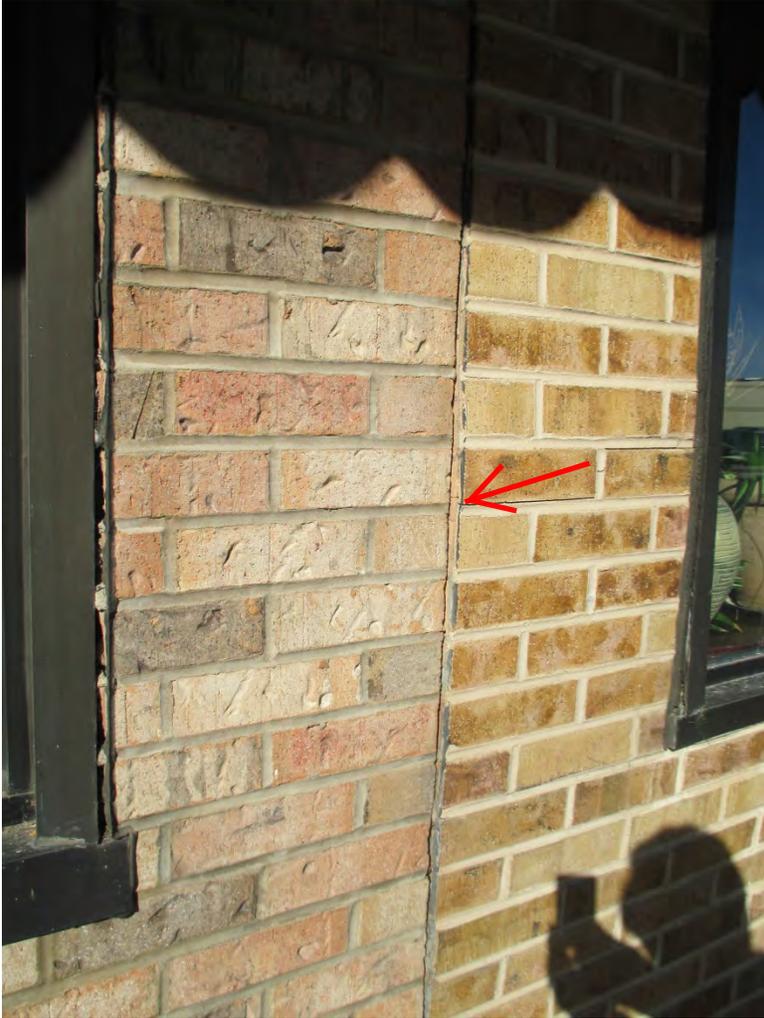
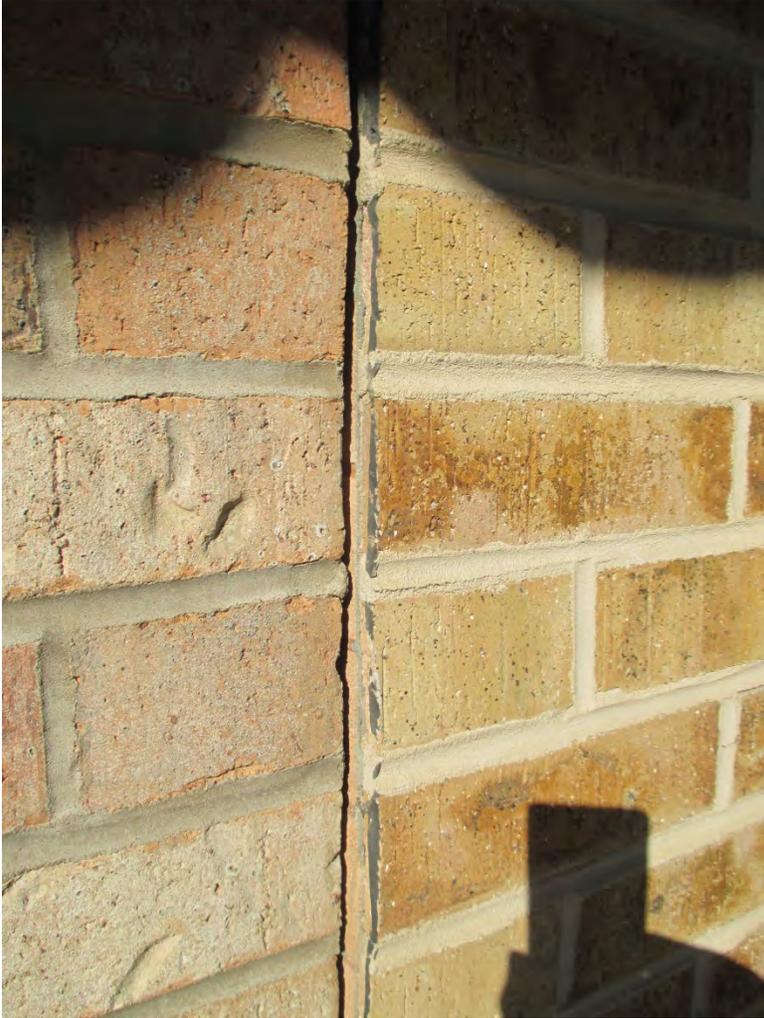
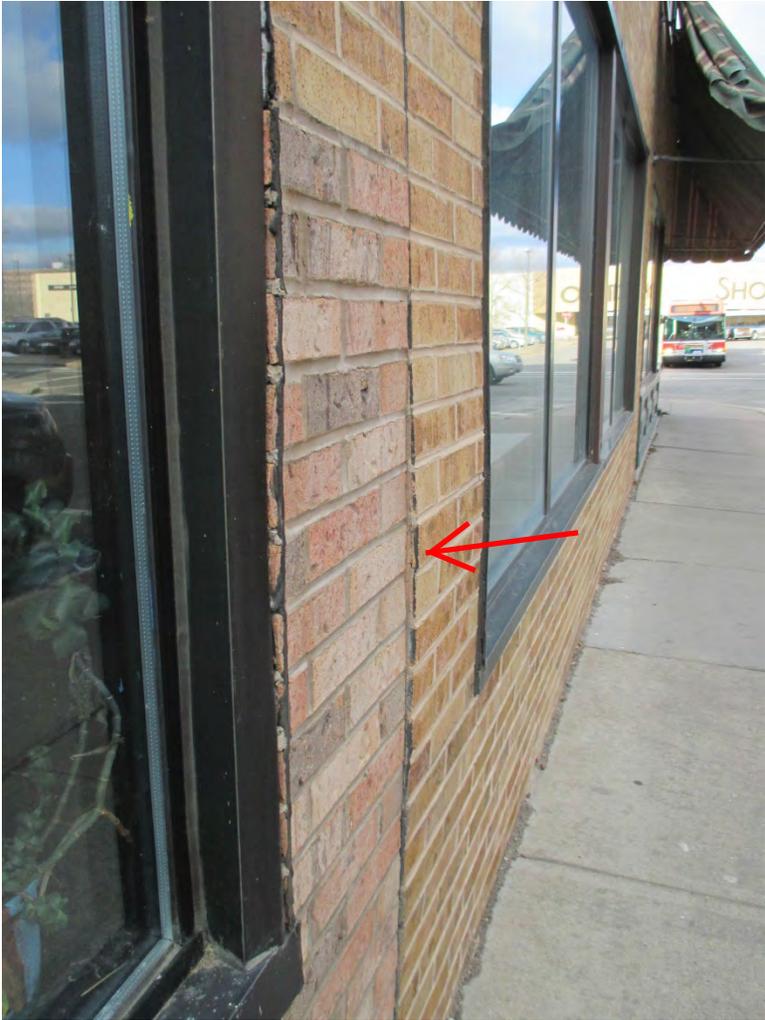
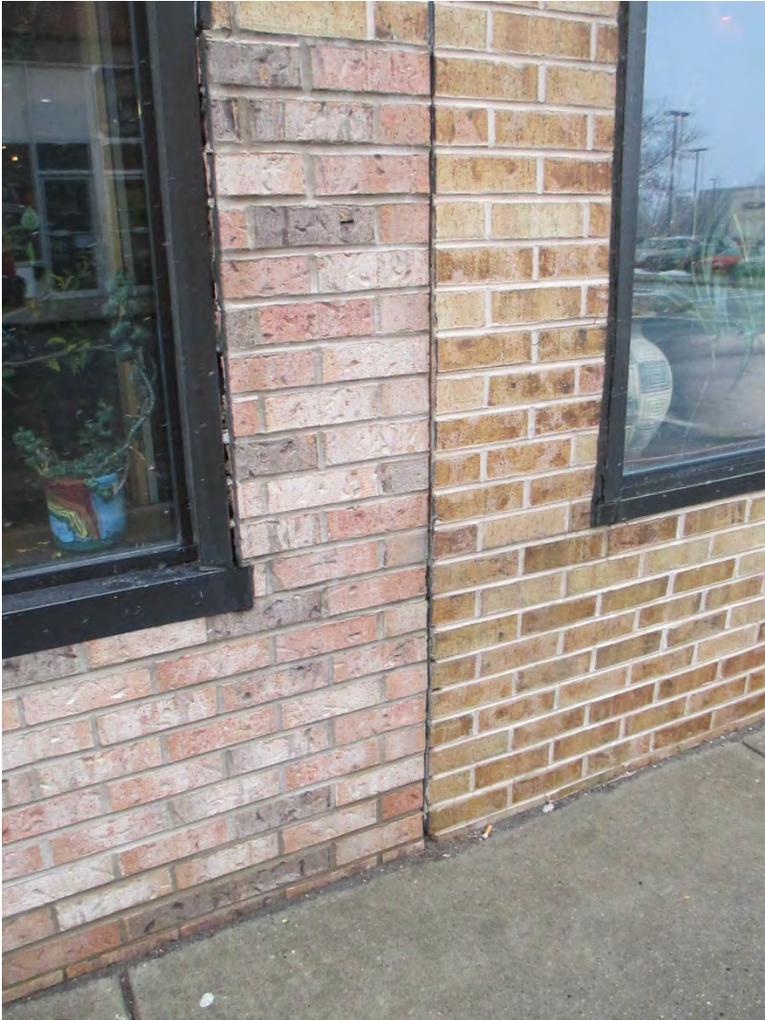
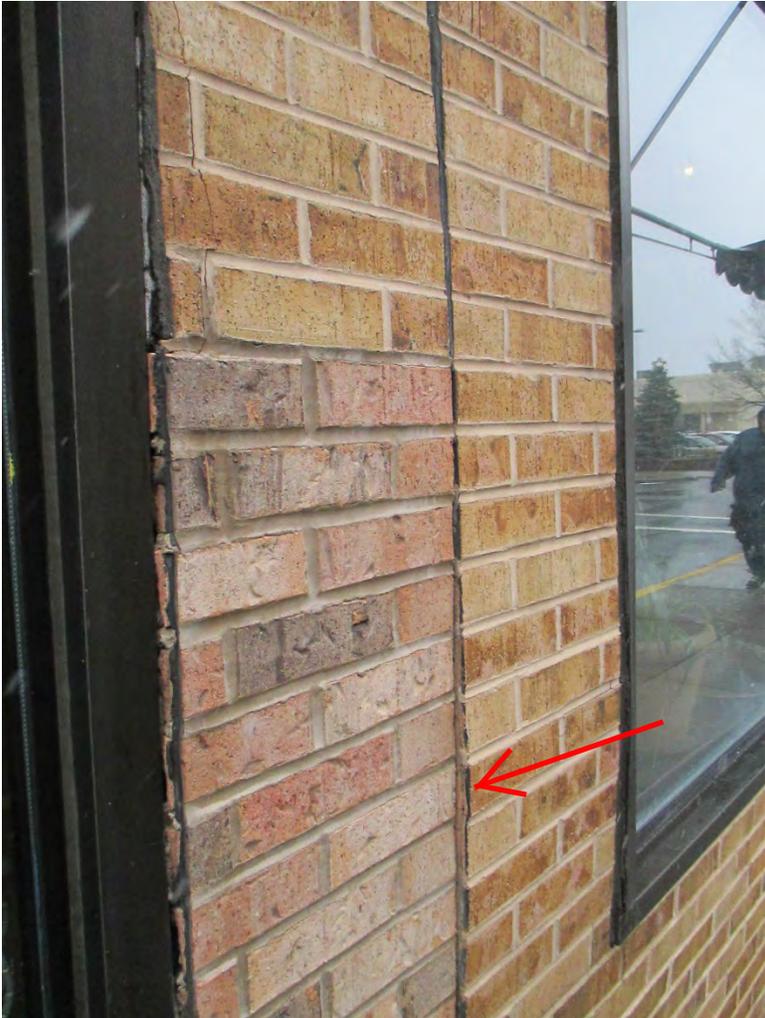
3. The masonry veneer below and to the north of the southernmost window is a different color than the remainder of the thin veneer. According to our correspondences subsequent to the site visit, a vehicle crashed into this area about ten years ago. It appears that the veneer used in the repair did not match the veneer applied in 1982 (photos 1-7).

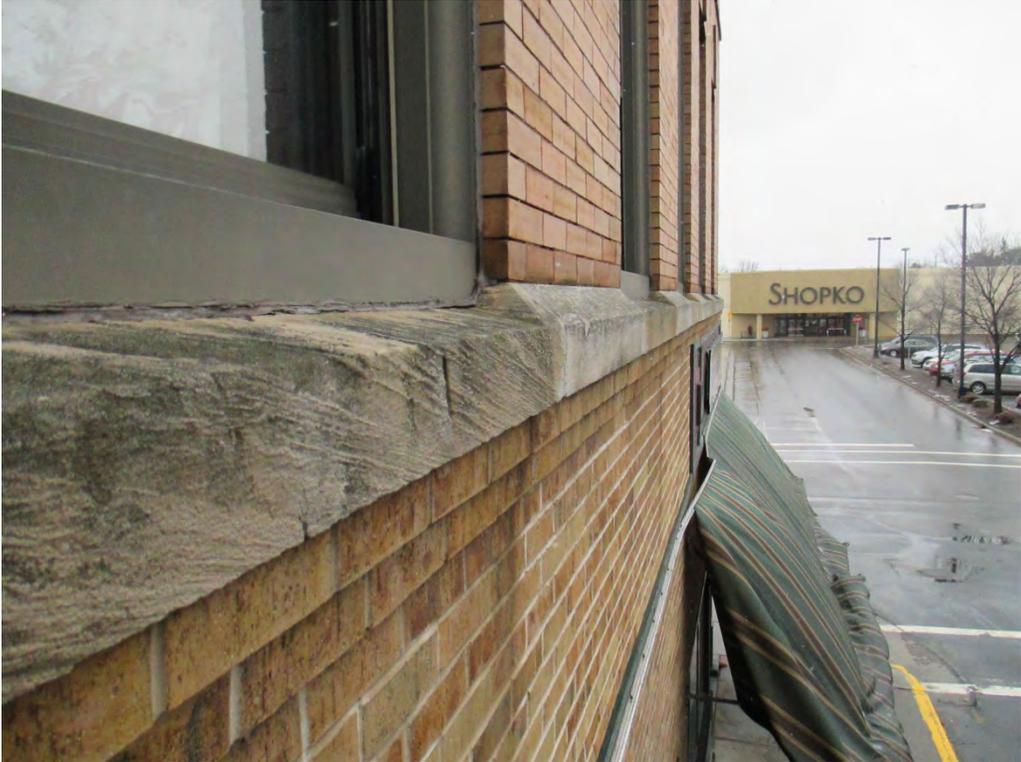
PHOTO 10

6. The joints between the stone sills below the second floor windows are slightly deteriorated (photos 10 & 11).
7. The caulking around the windows at the second floor appears somewhat deteriorated.

1. Eliminate all possible sources of water infiltration by tuckpointing, caulking and sealing open joints. Additional flashing may also be required.
2. Remove the canopy. If a canopy is to be installed in the future, the anchorage should extend into the structural wythe of the masonry.
3. The top of the walls below the first floor windows should be amended and braced to an element which adequately spans horizontally between the adjacent masonry piers.
4. Inspect the roof membrane and wall flashing to verify that water is not infiltrating the masonry from the roof or parapet walls.

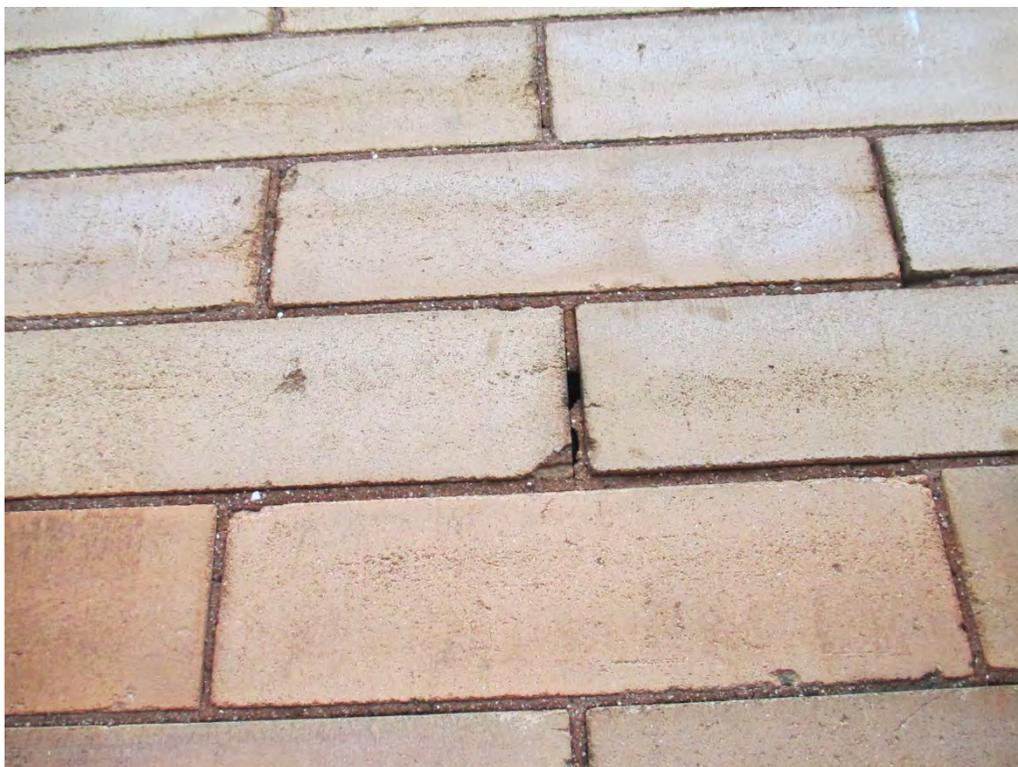
PHOTO 12

8. The original brick masonry above the bottom of the second floor windows is shown in photos 12 and 13. The joints are approximately $\frac{3}{16}$ " wide and are fairly deteriorated.

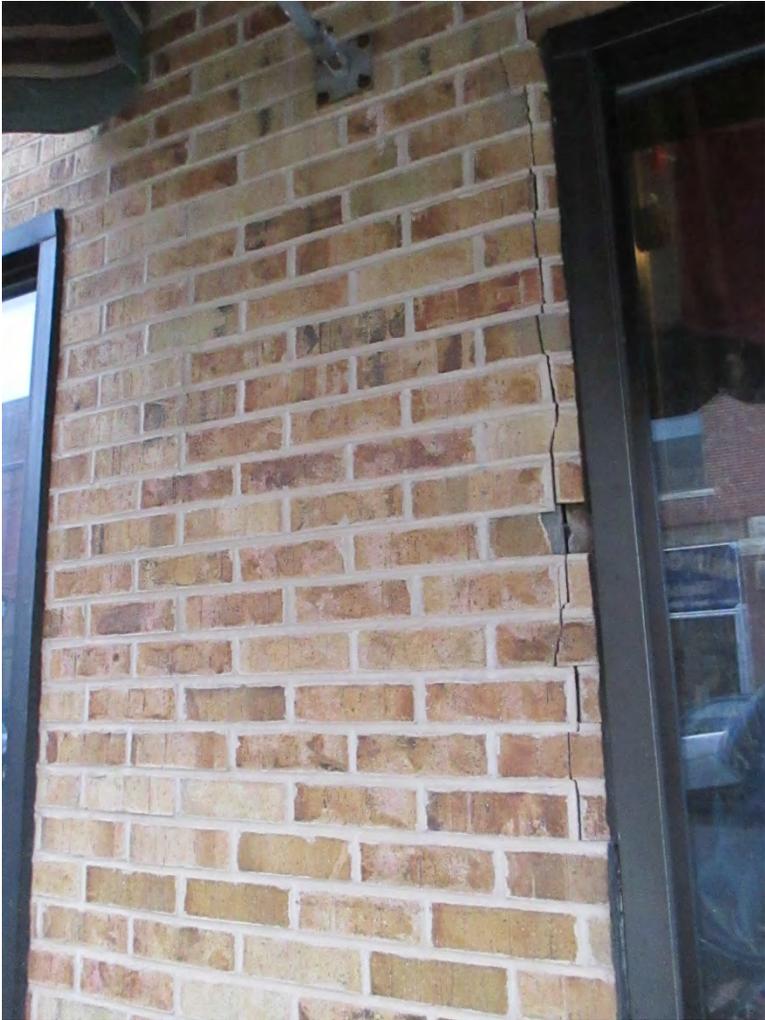
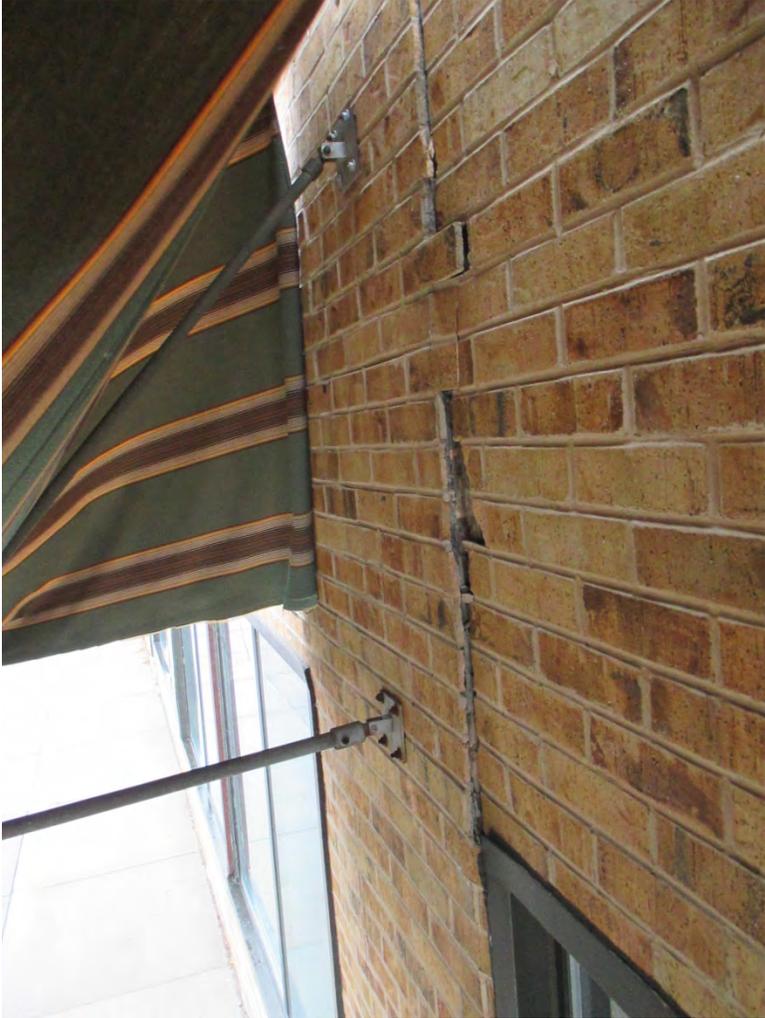
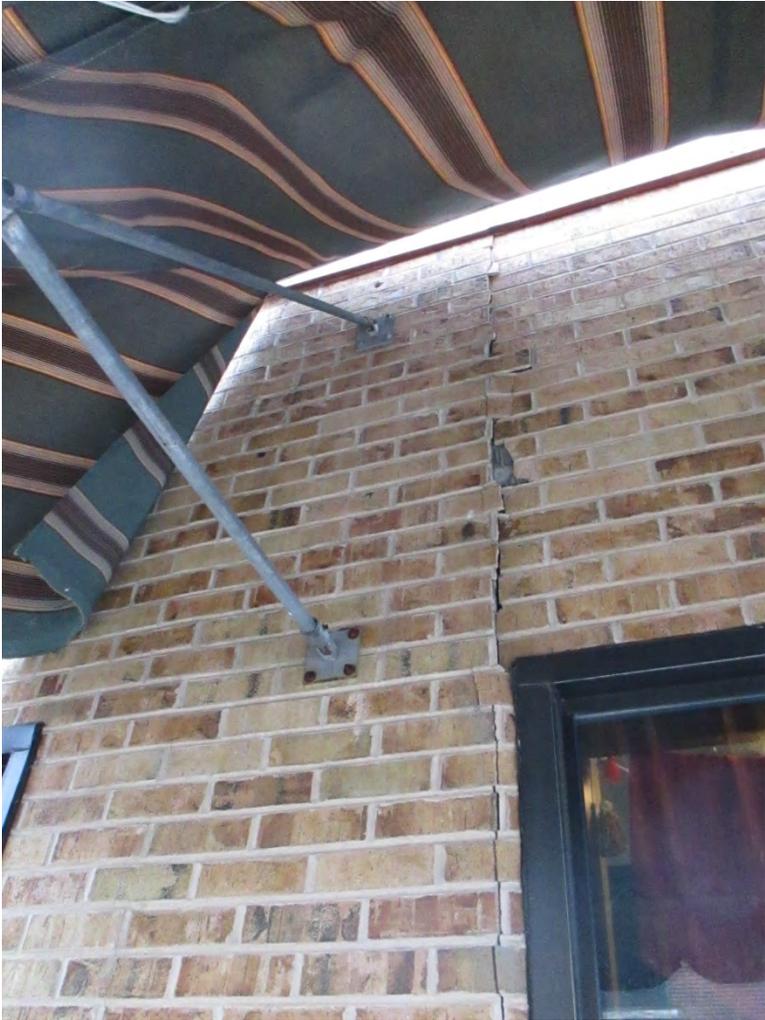
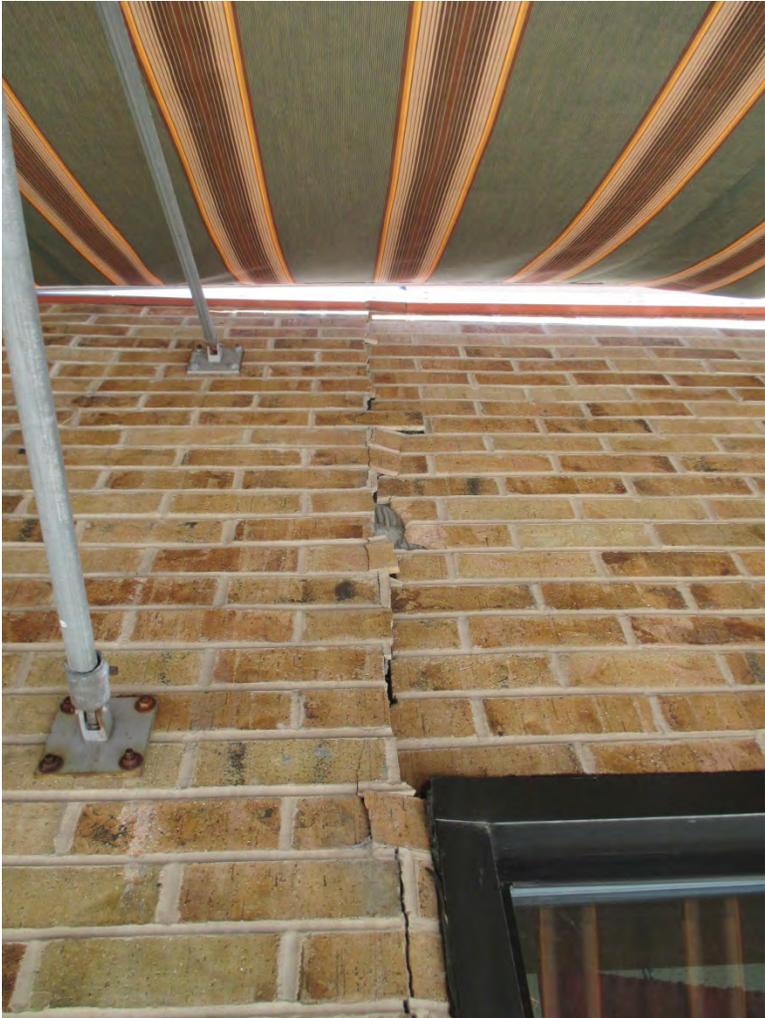
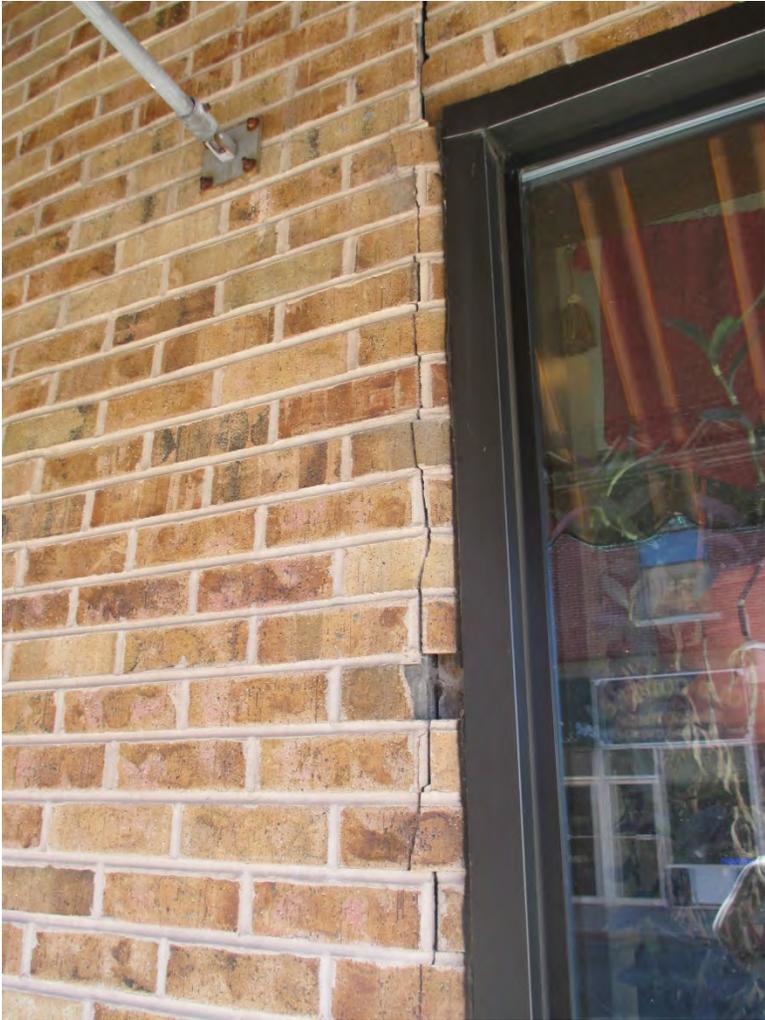
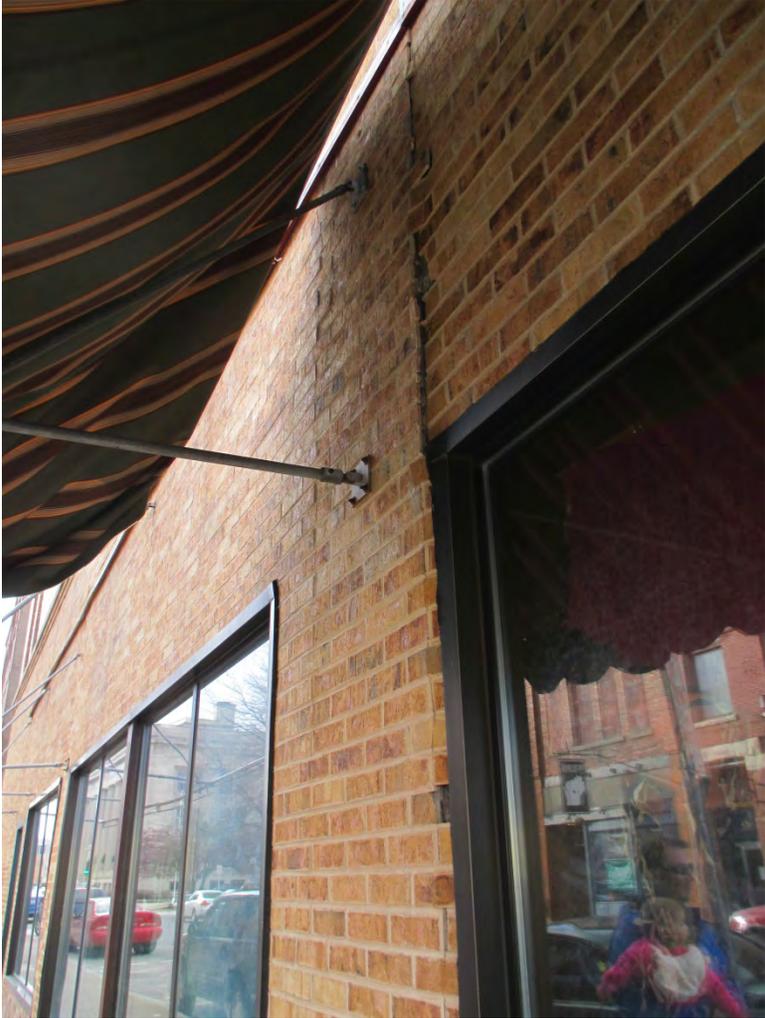
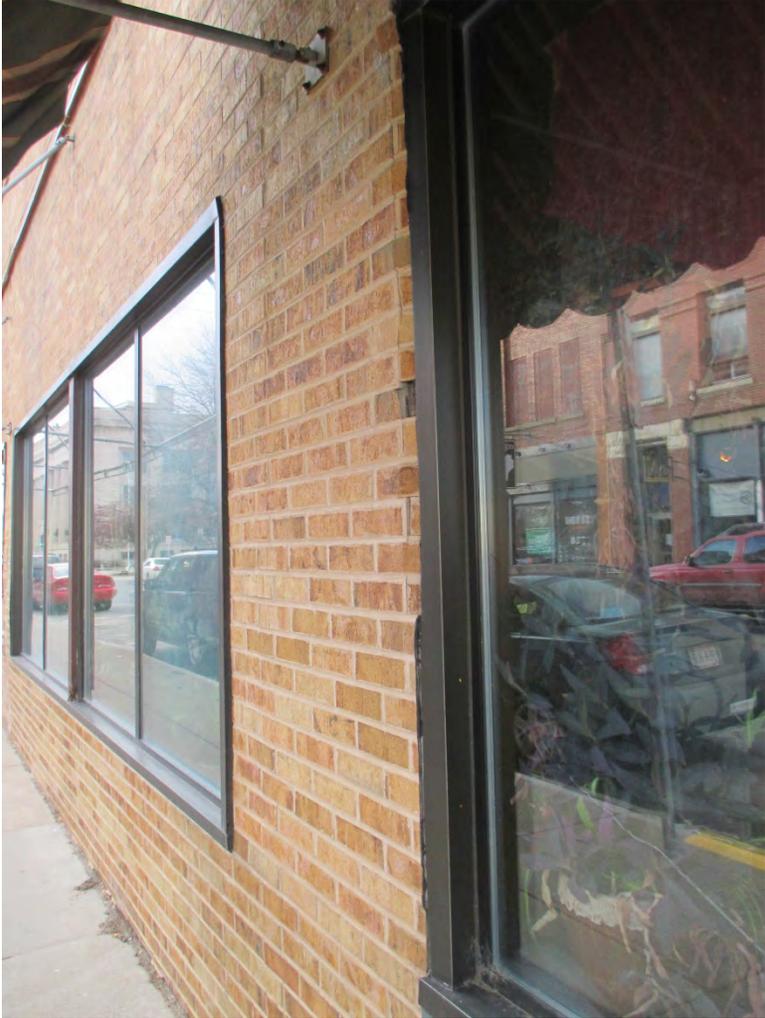
9. The thin veneer joint which is two courses above the canopy attachment is cracked and displaced. The veneer below the crack appears sloped and pushed inward. The course which the canopy is attached to appears to be somewhat pulled outward. The anchors which attach the canopy to the masonry veneer appear to be small and shallow (photos 14-21).
10. The masonry pier between the large central window and the northernmost window is bowed outward (photos 23-29).
11. The brick veneer is cracked along the south edge of the northernmost window. The cracks appear to be the result of a significant outward bow of the pier with respect to the masonry above the northernmost window (photos 23-29).

4. The deteriorated caulked joints permit water to infiltrate into the masonry.
5. The canopy attachment does not appear to have been sufficiently anchored to the structural brick wythe behind the thin veneer. As a result, it is likely that the wind loads on the canopy attachment have produced tensile and prying loads on the thin brick veneer. This combination of forces has likely caused the crack above the canopy attachment. Additional water is permitted to enter the masonry through this large crack.
